VEHICLE INSPECTION REPORT

LG21ZYW

Kia Sportage 1.6 CRDi 48V ISG 2 5dr DCT Auto

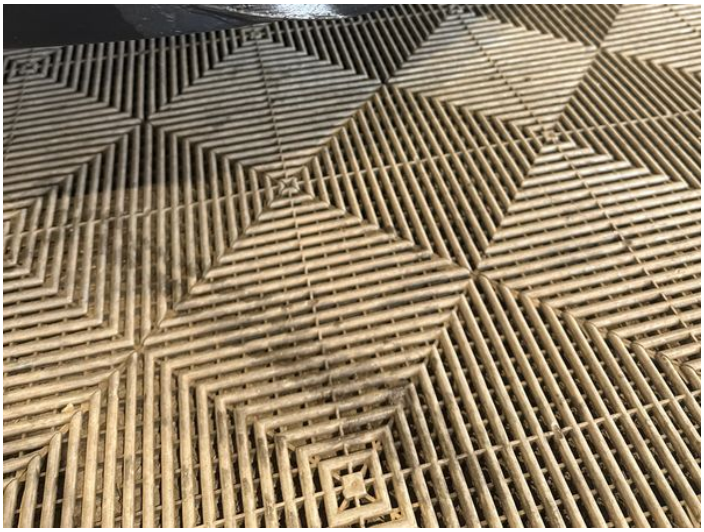
1: Bonnet
Chipped
1 To 5

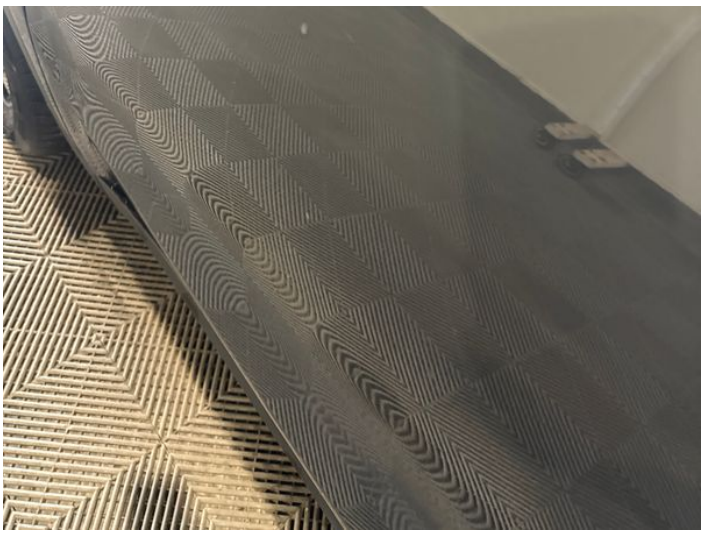
2: Bumper Front
Cracked
Over 25mm

3: Bumper Front Moulding
Broken
Replace
