VEHICLE INSPECTION REPORT

GY70YTE

Mercedes-Benz C Class C200 AMG Line Edition 2dr 9G-Tronic

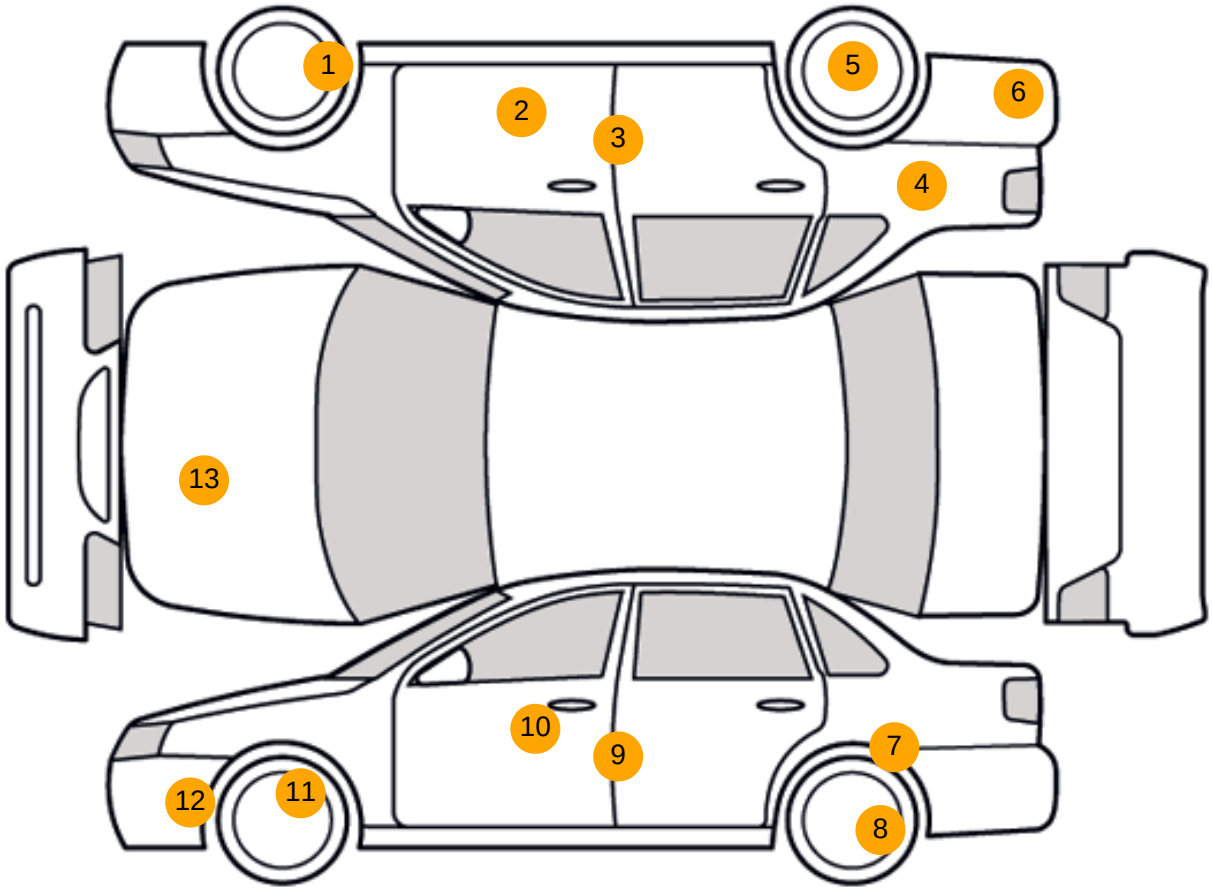
Damage Photos

1: Wheel osf
Scratched
Over 50mm

2: Door osf
Chipped
1 To 5

3: Door osf
Chipped
Edge Chip

4: Qtr Panel osr
Scratched
UpTo 25mm Thru Paint

5: Wheel osr
Corroded
Light

6: Bumper Rear
Scratched
25 to 100mm Thru Paint

7: Qtr Panel nsr
Scratched
UpTo 25mm Thru Paint

8: Wheel nsr
Corroded
Light

9: Door nsf
Chipped
Edge Chip

10: Door nsf
Chipped
1 To 5

11: Wheel nsf
Scratched
Up To 50mm

12: Bumper Front
Poor Previous Repair
Poor Paint

13: Bonnet
Chipped
1 To 5
