# VEHICLE INSPECTION REPORT

**GU65HKO**

## Mazda 2 1.5 75 SE-L 5dr

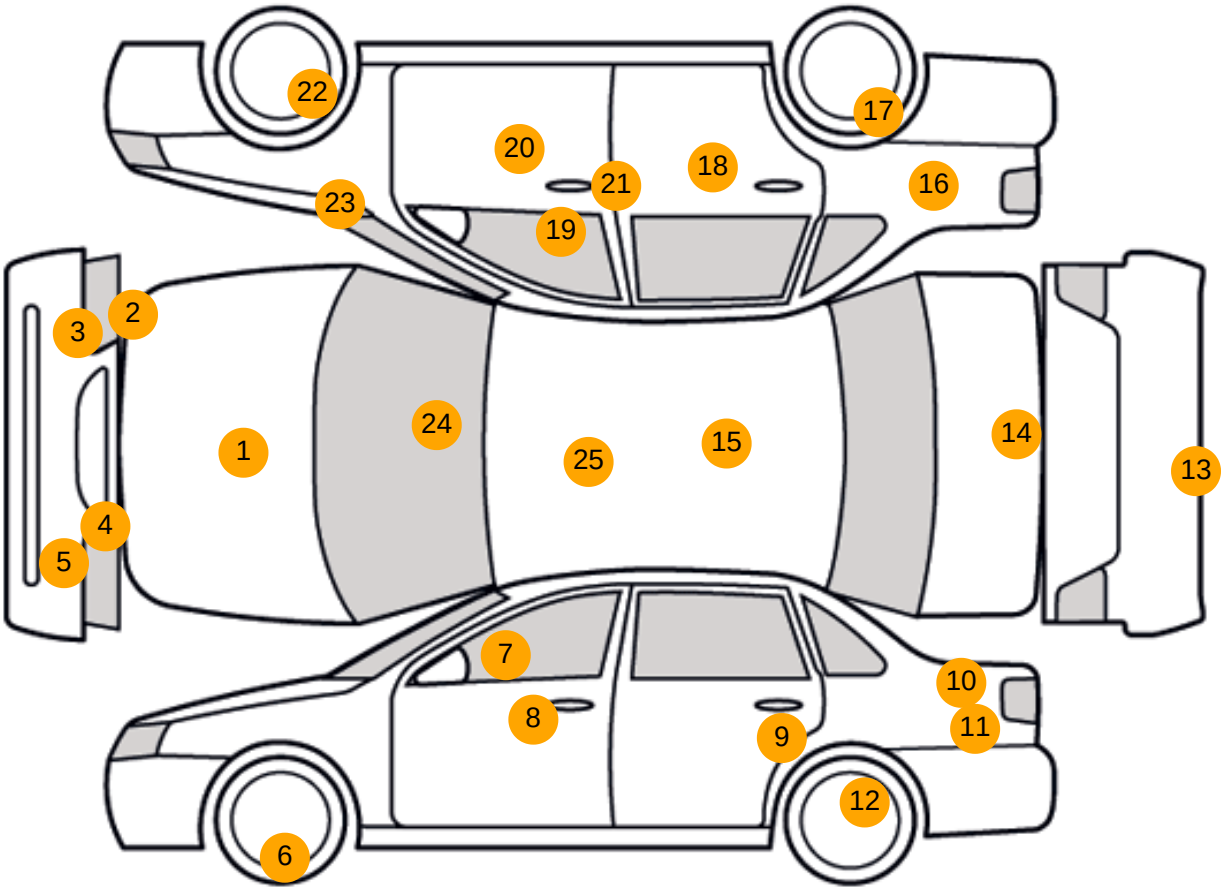
1: Bonnet
Poor Previous Repair
Paint Flake

2: Other
N/A
N/A
Headlights clouded

3: Fogdriving Lamp osf
Broken
Replace

4: Bumper Front
Scratched
25 to 100mm Thru Paint

5: Bumper Front
Scratched
25 to 100mm Thru Paint

6: Wheel nsf
Scratched
Over 50mm

7: A Post ns
Chipped
1 To 5

8: Door nsf
Chipped
Edge Chip

9: Door nsr
Dented
With Paint Damage

10: Qtr Panel nsr
Dented
2 Or Less UpTo 10mm

11: Qtr Panel nsr
Scratched
UpTo 25mm Thru Paint

12: Wheel nsr
Scratched
Over 50mm

13: Bumper Rear
Scratched
Over 100mm Thru Paint

14: Boot Lid
Dented
With Paint Damage

15: Roof
Dented
Over 30mm

16: Qtr Panel osr
Scratched
UpTo 25mm Thru Paint

17: Wheel osr
Corroded
Light

18: Door osr
Scratched
Over 25mm Thru Paint

19: Door osf
Chipped
Edge Chip

20: Door osf
Dented
2 Or Less UpTo 10mm

21: Handle Outer osf
Scratched (Painted)
UpTo 25mm Thru Paint

22: Wheel osf
Scratched
Over 50mm

23: Wing osf
Chipped
1 To 5

24: Screen Front
Chipped
Over 10mm

25: Other
N/A
N/A
Steering wheel scuffed

26: Roof
Chipped
1 To 5
