VEHICLE INSPECTION REPORT

GY65WMM

Nissan Qashqai 1.2 DiG-T N-Tec+ 5dr

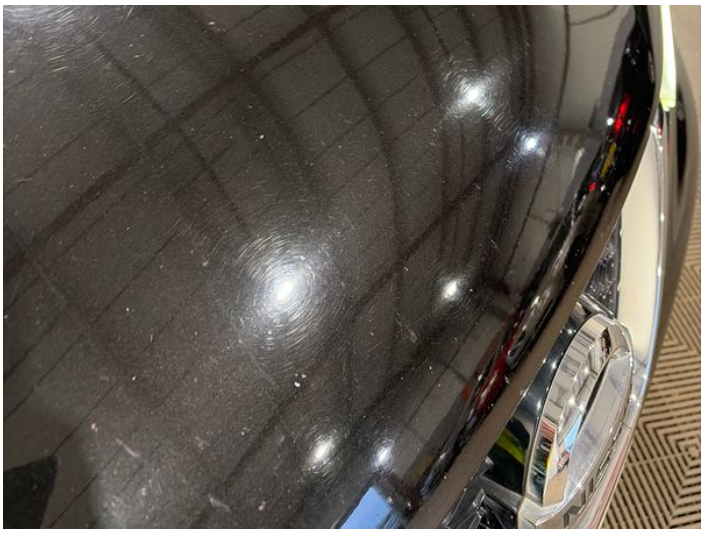
1: Carpets Front
Scuffed
Over 25mm

2: Bonnet
Chipped
Multiple Chips

3: Bumper Front
Scratched
25 to 100mm Thru Paint

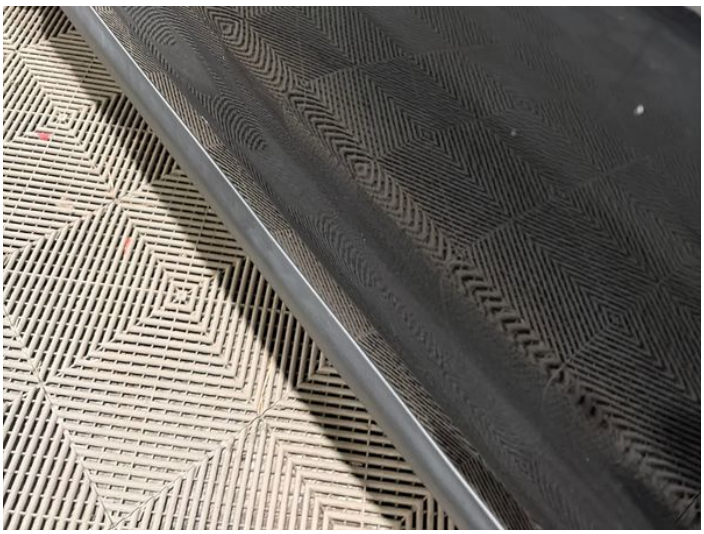
4: Bumper Front
Scratched
25 to 100mm Thru Paint

5: Wheel nsf
Scratched
Over 50mm

6: Wing nsf
Chipped
1 To 5

7: Door nsf
Scratched
Over 25mm Thru Paint

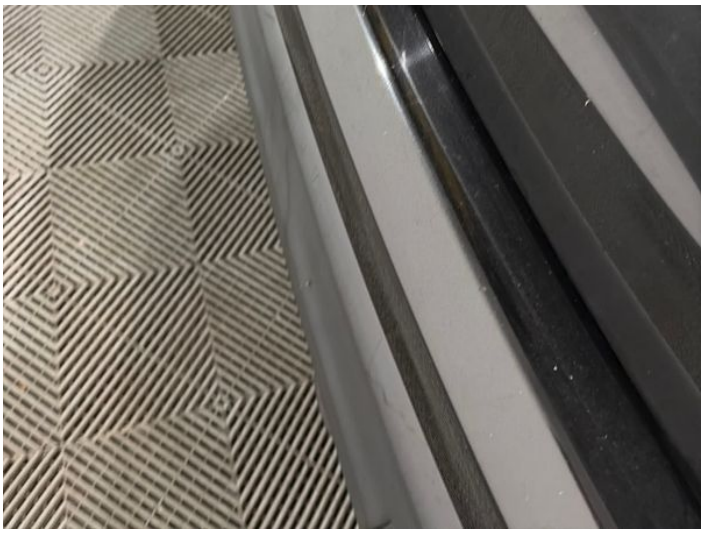
8: Door nsr
Scratched
Over 25mm Thru Paint

9: Wheel nsr
Scratched
Over 50mm

10: Qtr Panel nsr
Scratched
Over 25mm Thru Paint

11: Bumper Rear
Scratched
25 to 100mm Thru Paint

12: Boot Lid
Scratched
UpTo 25mm Thru Paint

13: Qtr Panel osr
Scratched
UpTo 25mm Thru Paint

14: Wheel osr
Scratched
Over 50mm

15: Door osr
Scratched
Over 25mm Thru Paint

16: Door osf
Scratched
Over 25mm Thru Paint

17: Wing osf
Dented
Between 10mm + 30mm

18: Wing osf
Chipped
1 To 5
