VEHICLE INSPECTION REPORT

GV67NXU

Kia Niro 1.6 GDi PHEV 3 5dr DCT

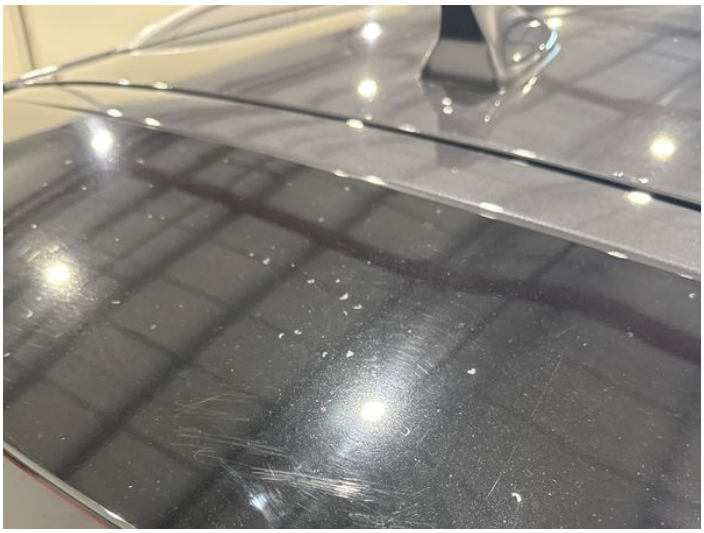
1: Bonnet
Chipped
1 To 5

2: Bumper Front
Scratched
25 to 100mm Thru Paint

3: Wheel Trim nsf
Scratched
Over 50mm

4: Wing nsf
Chipped
1 To 5

5: Door nsf
Scratched
Over 25mm Thru Paint

6: Door nsr
Dented
Between 10mm + 30mm

7: Door nsr
Scratched
Over 25mm Thru Paint
