VEHICLE INSPECTION REPORT

YE64KXM

Nissan Juke 1.2 DiG-T Acenta Premium 5dr

Cat: S | Incident History

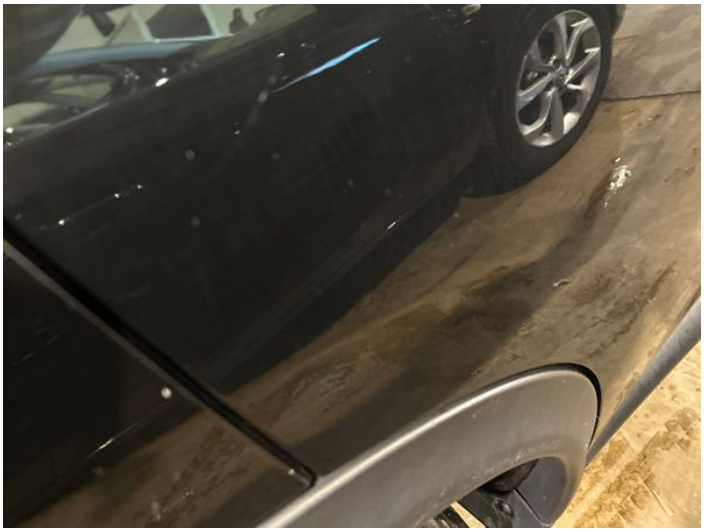
Damage Photos

1: Wheel osf
Scratched
Over 50mm

2: Wing osf
Chipped
1 To 5

3: Door osf
Scratched
Over 25mm Thru Paint

4: Door osr
Chipped
1 To 5

5: Wheel osr
Scratched
Over 50mm

6: Qtr Panel osr
Chipped
1 To 5

7: Bumper Rear
Chipped
Multiple Chips

8: Bumper Rear
Scratched
Up To 25mm Thru Paint

9: Qtr Panel nsr
Dented
Between 10mm + 30mm

10: Door nsr
Scratched
Over 25mm Thru Paint

11: Door nsf
Dented
With Paint Damage

12: Wheel nsf
Corroded
Light

13: Wing nsf
Chipped
1 To 5

14: Bumper Front
Chipped
Multiple Chips

15: Bonnet
Chipped
1 To 5

16: Screen Front
Chipped
UpTo 10mm

17: Roof
Scratched
UpTo 25mm Thru Paint
