VEHICLE INSPECTION REPORT

SM12FVL

Nissan Qashqai 2.0 N-Tec+ 5dr CVT

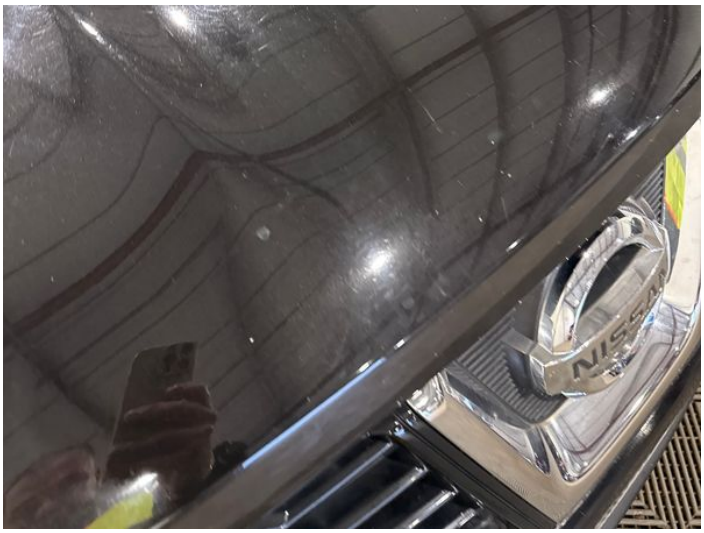
1: Bonnet
Chipped
Multiple Chips

2: Bumper Front
Poor Previous Repair
Paint Flake

3: Wheel nsf
Scratched
Over 50mm

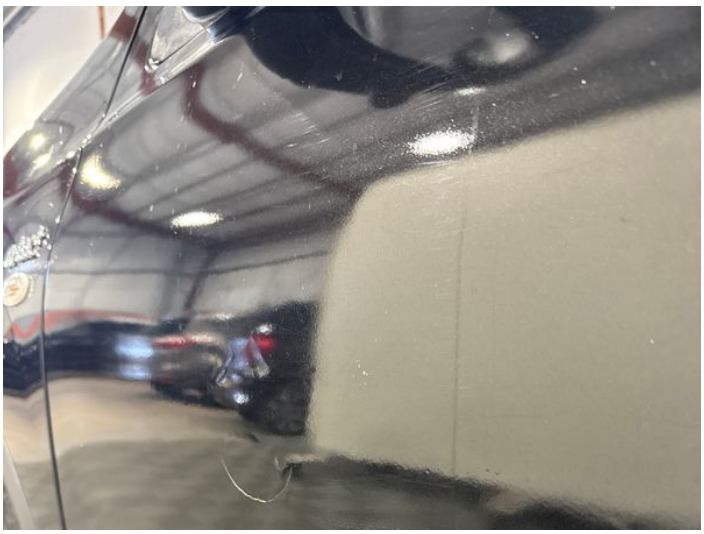
4: Wing nsf
Scratched
UpTo 25mm Thru Paint

5: Door Mirror Assy nsf
Scratched (Painted)
Over 25mm Thru Paint

6: A Post ns
Scratched
Over 25mm Thru Paint

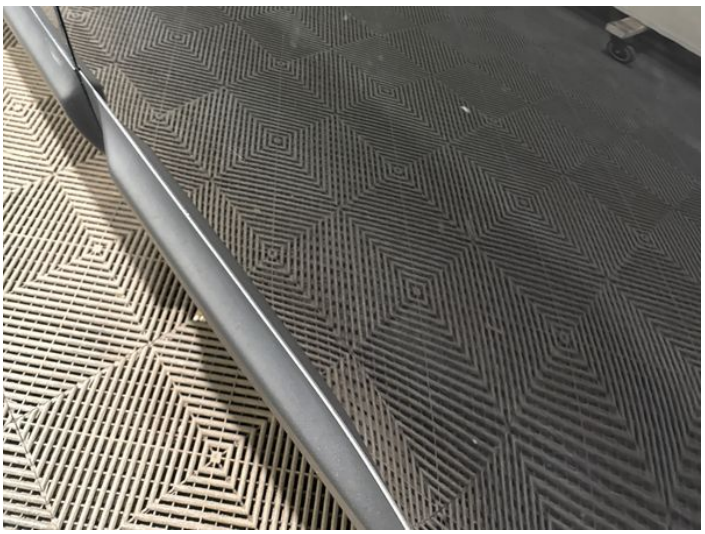
7: Door nsf
Poor Previous Repair
Rippled UpTo 30%

8: Door nsr
Scratched
Over 25mm Thru Paint

9: Qtr Panel Arch Extension ns
Broken
Replace

10: B Post ns
Scratched
Over 25mm Thru Paint

11: Wheel nsr
Scratched
Over 50mm

12: Bumper Rear
Poor Previous Repair
Paint Flake

13: Boot Lid
Scratched
UpTo 25mm Thru Paint

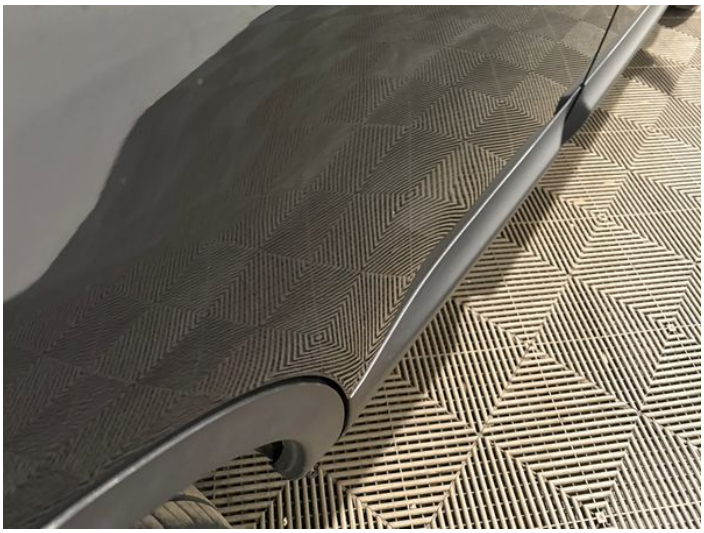
14: Qtr Panel osr
Dented
Between 10mm + 30mm

15: Wheel osr
Scratched
Over 50mm

16: Qtr Panel osr
Scratched
UpTo 25mm Thru Paint

17: Door osr
Dented
Over 30mm

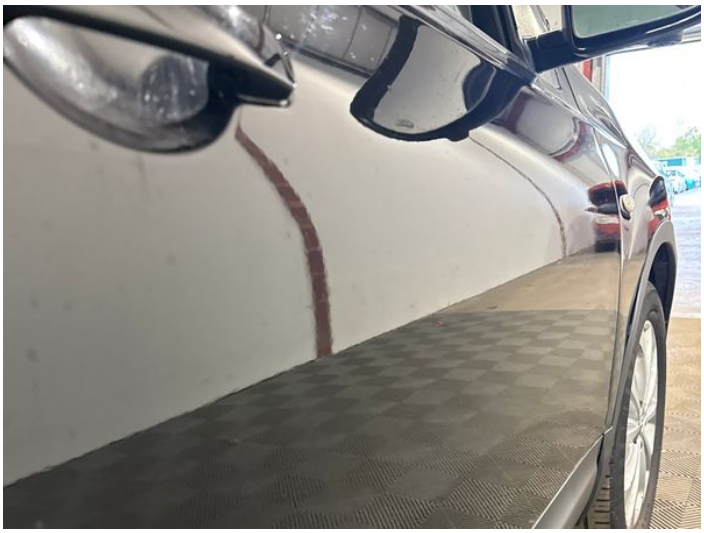
18: Door osf
Dented
With Paint Damage

19: Wing osf
Poor Previous Repair
Poor Paint

20: Wheel osf
Scratched
Over 50mm

21: Screen Front
Chipped
UpTo 10mm

22: Aperture Seal osf
Broken
Replace

23: Other
N/A
N/A
Roof rails scratched

24: Seat Base Cover osf
Scuffed
Over 25mm

25: Fascia Trim
Damaged
Replace

26: Tyre osf
Damaged
Replace
