VEHICLE INSPECTION REPORT

GL69MVV

Ford Focus 1.0 EcoBoost 125 Active X Auto 5dr

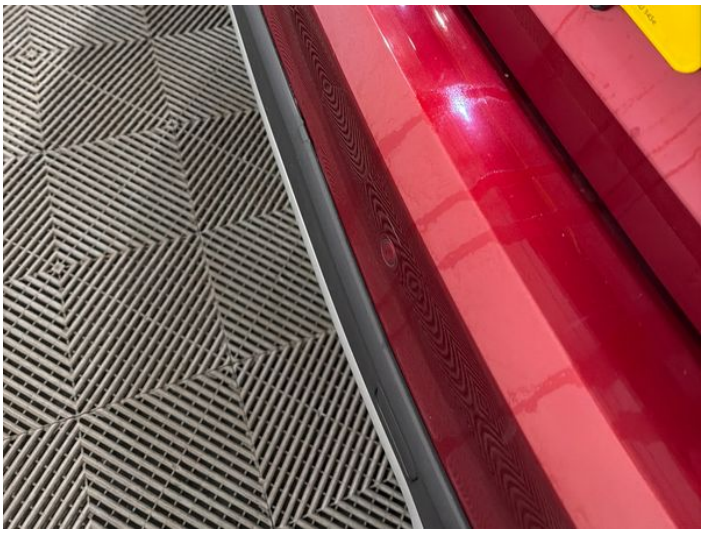
3: Wheel nsf
Scratched
Over 50mm

4: Wing nsf
Chipped
1 To 5

5: A Post ns
Chipped
1 To 5

6: Screen Front
Chipped
UpTo 10mm

7: Door nsf
Chipped
Edge Chip

8: Door nsf
Dented
Between 10mm + 30mm

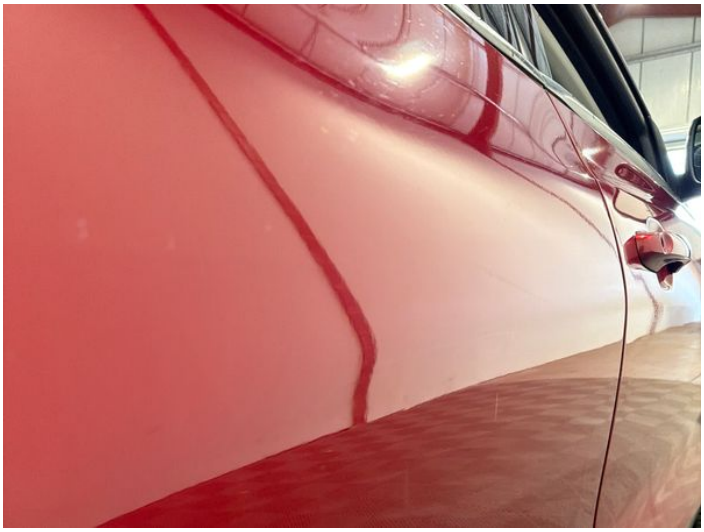
9: Door nsr
Dented
With Paint Damage

10: Qtr Panel nsr
Dented
With Paint Damage

11: Qtr Panel Arch Extension ns
Scuffed (Unpainted)
Over 100mm

12: Bumper Rear
Scratched
25 to 100mm Thru Paint

13: Boot Lid
Chipped
1 To 5
