VEHICLE INSPECTION REPORT

OY15KZR

Audi A6 2.0 TDI Ultra S Line 4dr

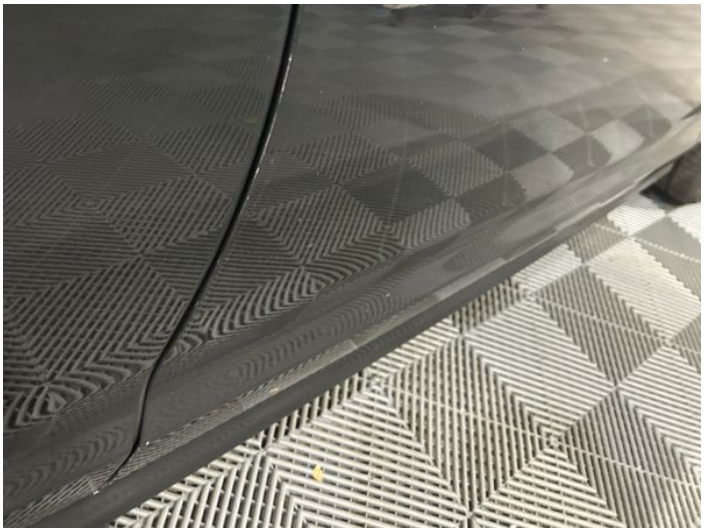
1: Wheel osf
Scratched
Over 50mm

2: Wing osf
Chipped
1 To 5

3: Door osf
Scratched
UpTo 25mm Thru Paint

4: Door osf
Chipped
Edge Chip

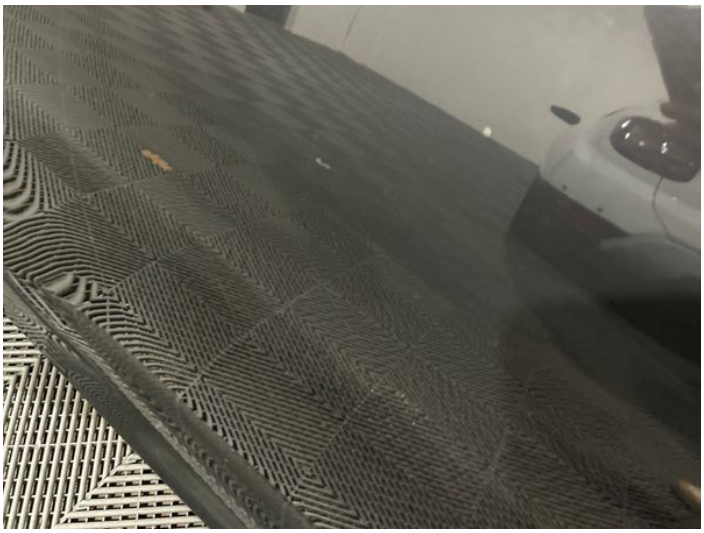
5: Door osr
Chipped
1 To 5

6: Wheel osr
Scratched
Over 50mm

7: Bumper Rear
Scratched
Over 100mm Thru Paint

8: Qtr Panel nsr
Scratched
Over 25mm Thru Paint

9: Wheel nsr
Scratched
Over 50mm

10: Door nsr
Scratched
Over 25mm Thru Paint

11: Door nsf
Dented
With Paint Damage

12: Wing nsf
Dented
With Paint Damage

13: Wheel nsf
Scratched
Over 50mm

14: Bumper Front
Scratched
Over 100mm Thru Paint

15: Bonnet
Chipped
Multiple Chips

16: Screen Front
Chipped
UpTo 10mm
