VEHICLE INSPECTION REPORT

LD11JWG

Volvo XC60 D3 [163] SE 5dr Geartronic

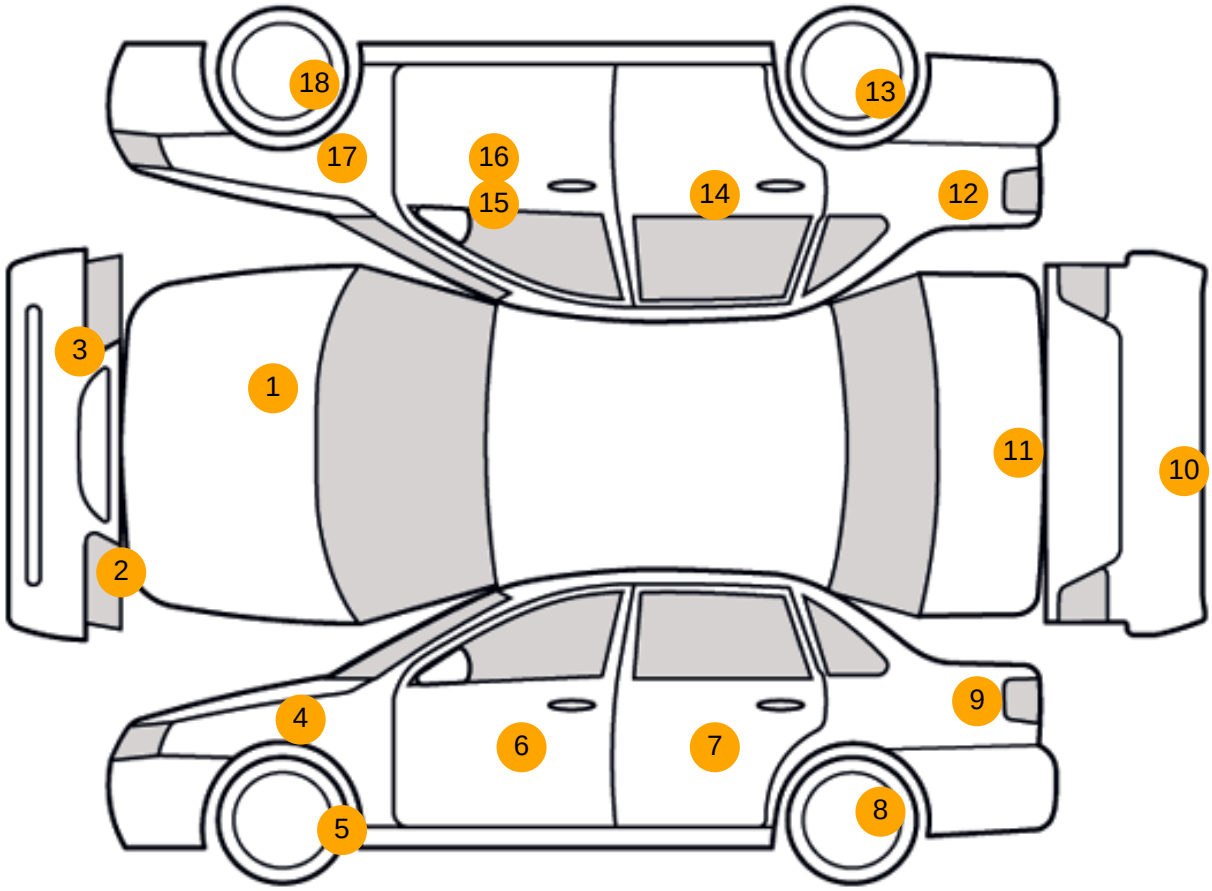
1: Centre Console Front
Scuffed
Over 25mm

2: Bonnet
Chipped
1 To 5

3: Other
N/A
N/A
Headlights scratched

4: Bumper Front
Scratched
25 to 100mm Thru Paint

5: Other
N/A
N/A
Bonnet out line

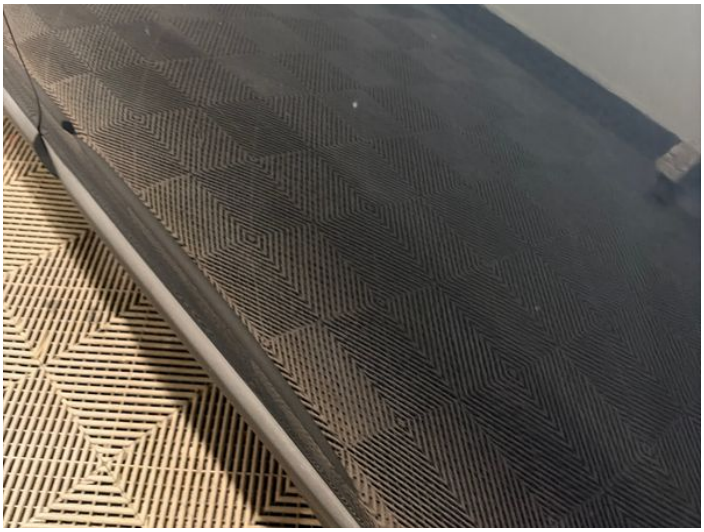
6: Wing nsf
Chipped
1 To 5

7: Wheel nsf
Scratched
Up To 50mm

8: Door nsf
Scratched
Over 25mm Thru Paint

9: Door nsr
Chipped
1 To 5

10: Wheel nsr
Scratched
Over 50mm

11: Qtr Panel nsr
Chipped
1 To 5

12: Bumper Rear
Dented
With Paint Damage

13: Boot Lid
Chipped
1 To 5

14: Qtr Panel osr
Scratched
Over 25mm Thru Paint

15: Wheel osr
Scratched
Over 50mm

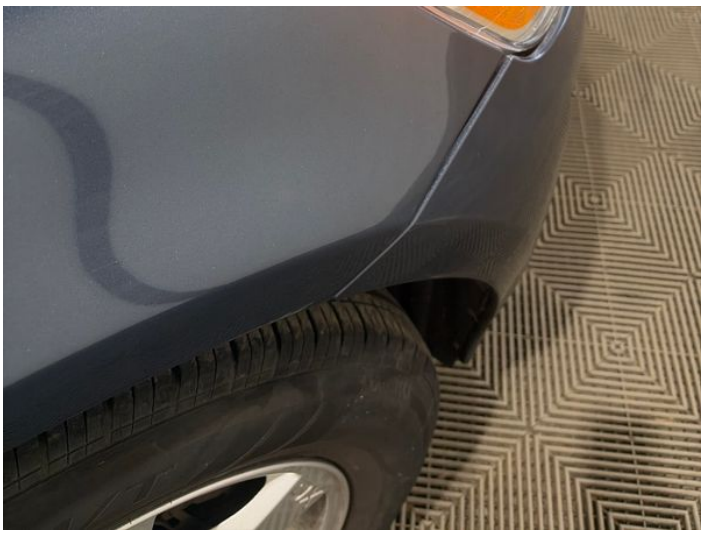
16: Door osr
Poor Previous Repair
Rippled UpTo 30%

17: Door osf
Chipped
Edge Chip

18: Door osf
Chipped
1 To 5

19: Wing osf
Chipped
1 To 5

20: Wheel osf
Scratched
Over 50mm
