VEHICLE INSPECTION REPORT

GU70PWF

BMW 1 Series 118i M Sport 5dr

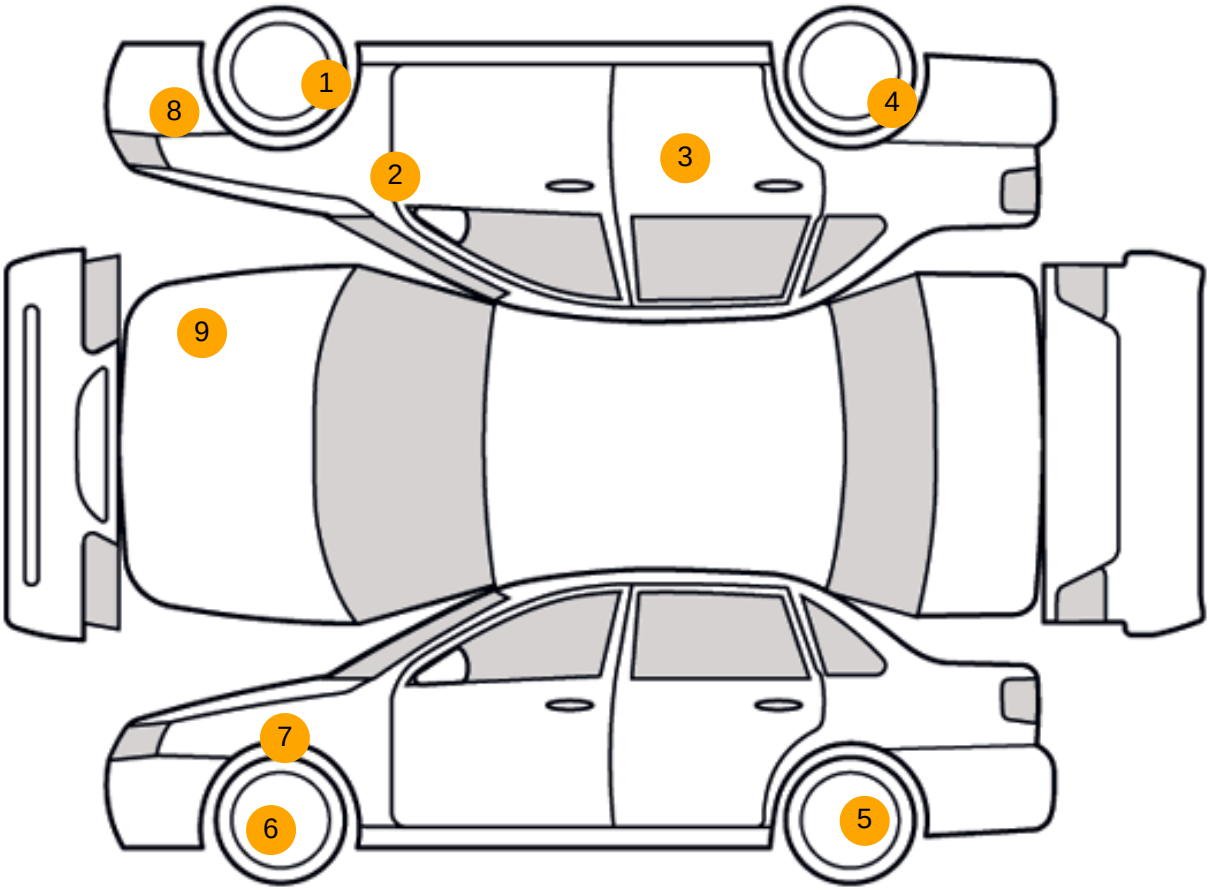
Condition Check

1: Wheel osf
Scratched
Over 50mm

2: Wing osf
Chipped
1 To 5

3: Door osr
Chipped
1 To 5

4: Wheel osr
Corroded
Light

5: Wheel nsr
Corroded
Light

6: Wheel nsf
Scratched
Over 50mm
