VEHICLE INSPECTION REPORT

GV17EOX

Audi A3 2.0 TDI S Line 2dr

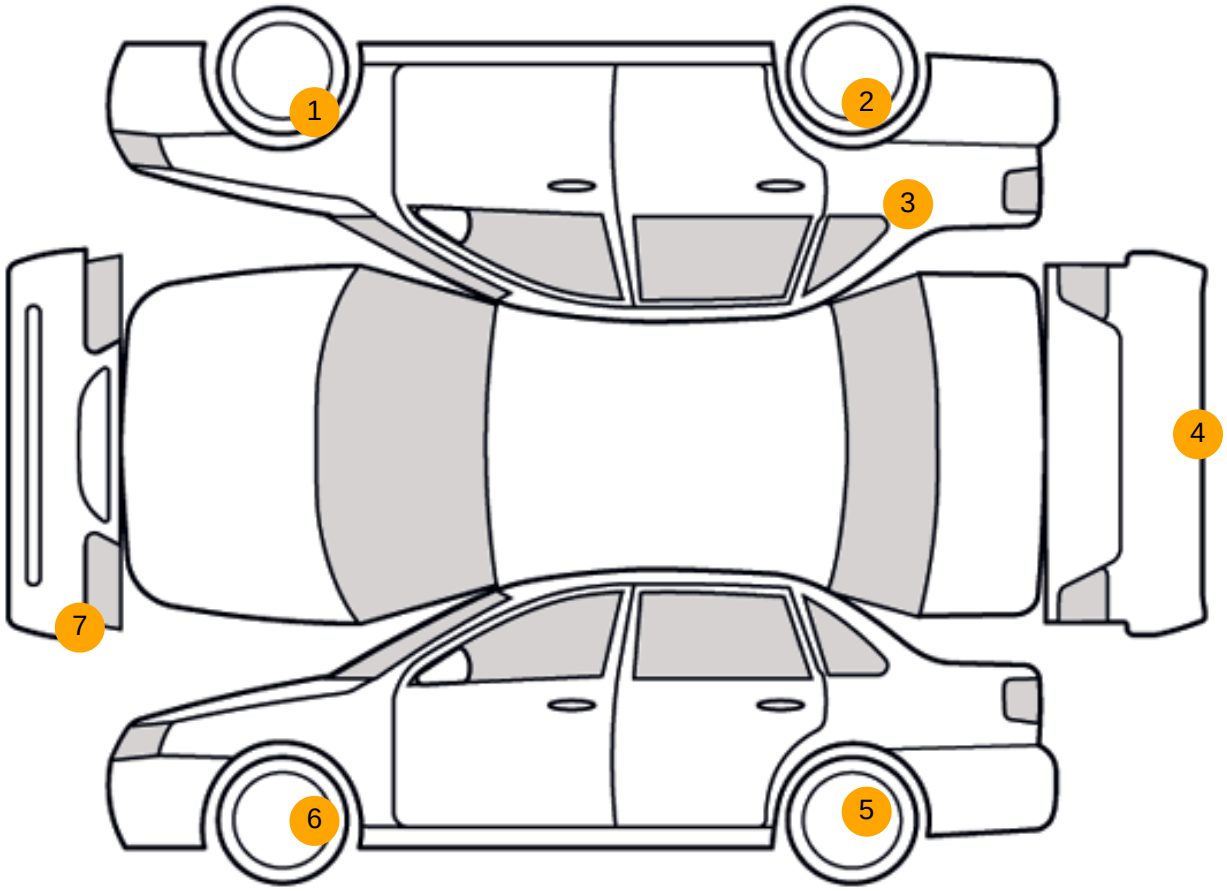
1: Wheel osf
Scratched
Over 50mm

2: Wheel osr
Scratched
Over 50mm

3: Qtr Panel osr
Poor Previous Repair
Poor Paint

4: Bumper Rear
Dented
With Paint Damage

5: Wheel nsr
Scratched
Over 50mm

6: Wheel nsf
Scratched
Over 50mm

7: Bumper Front
Chipped
Multiple Chips
