# VEHICLE INSPECTION REPORT

**DX20ZKK**

## Nissan X-Trail 1.7 dCi Acenta Premium 5dr

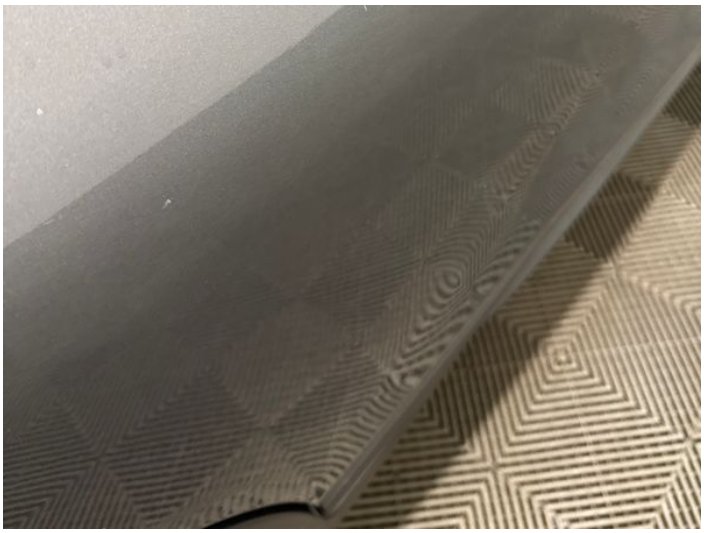
1: Bonnet
Chipped
1 To 5

2: Bumper Front
Chipped
1 To 5

3: Bumper Front
Chipped
Over 5mm

4: A Post ns
Chipped
1 To 5

5: Door nsf
Dented
2 Or Less UpTo 10mm

6: Door nsf
Chipped
1 To 5

7: Door nsr
Dented
Between 10mm + 30mm

8: Door nsr
Chipped
Edge Chip

9: Other
N/A
N/A
Trims missing on the roof

10: Bumper Rear
Poor Previous Repair
Poor Paint

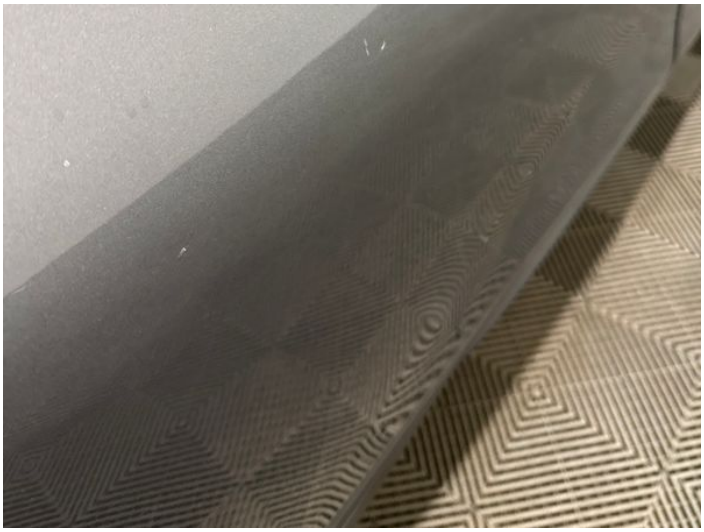
11: Bumper Reflector nsr
Broken
Replace

12: Qtr Panel osr
Chipped
1 To 5

13: Door osr
Chipped
Edge Chip

14: Door osr
Chipped
1 To 5
