VEHICLE INSPECTION REPORT

GY65CZX

Volkswagen Golf 1.4 TSI GT 2dr DSG

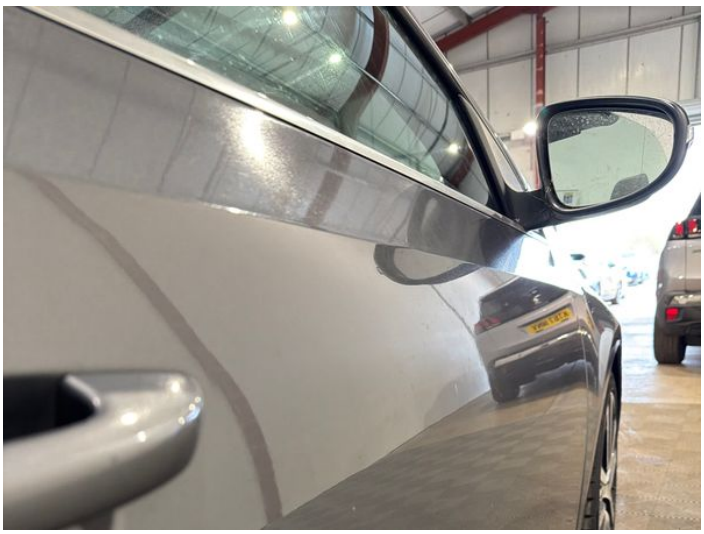
9: Wing nsf
Dented
Between 10mm + 30mm

10: Wing nsf
Chipped
1 To 5

11: Flasher Side Repeater ns
Broken
Replace

12: Door Mirror Assy nsf
Scratched (Painted)
UpTo 25mm Thru Paint

13: Door nsf
Poor Previous Repair
Rippled UpTo 30%

14: Wheel nsr
Scratched
Over 50mm

15: Qtr Panel nsr
Poor Previous Repair
Rippled UpTo 30%

16: Bumper Rear
Scratched
Over 100mm Thru Paint
