VEHICLE INSPECTION REPORT

KV14YBC

Audi Q5 2.0 TDI Quattro S Line 5dr

Condition Check

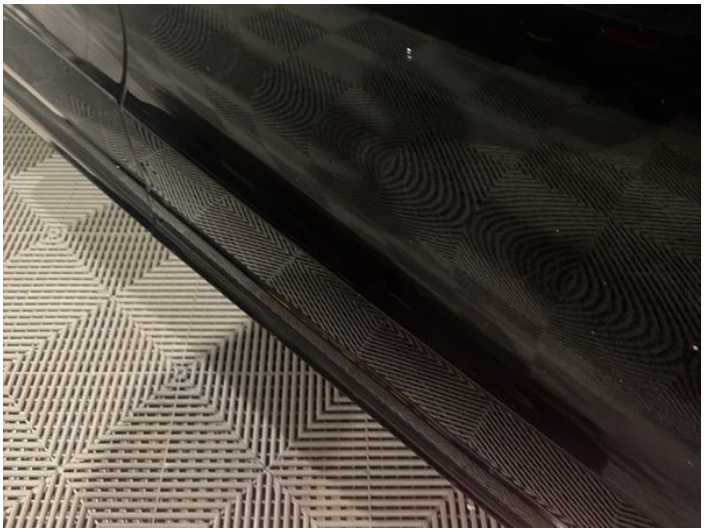
1: Wheel osf
Scratched
Over 50mm

2: Wing osf
Scratched
UpTo 25mm Thru Paint

3: Other
N/A
N/A

4: Door osf
Chipped
Multiple Chips

5: Door osr
Poor Previous Repair
Poor Paint

6: Wheel osr
Scratched
Over 50mm

7: Bumper Rear
Scratched
25 to 100mm Thru Paint

8: Wheel nsr
Scratched
Over 50mm

9: Qtr Panel nsr
Scratched
UpTo 25mm Thru Paint

10: Door nsr
Chipped
Edge Chip

11: Door nsr
Chipped
1 To 5

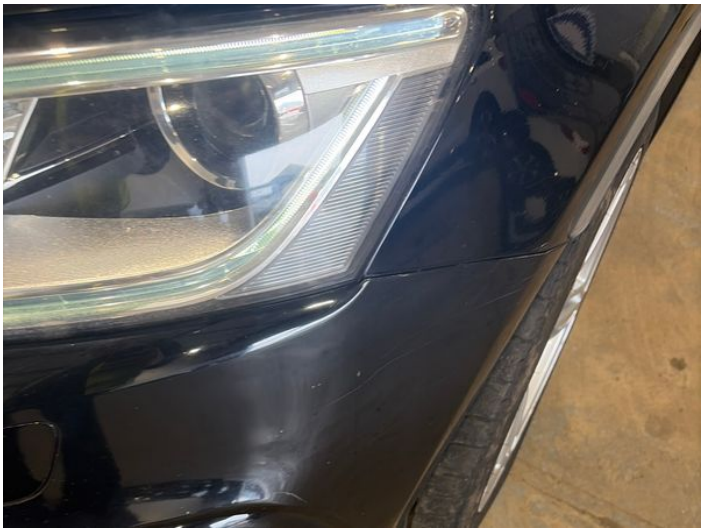
12: Door nsf
Chipped
Multiple Chips

13: Wheel nsf
Scratched
Over 50mm

14: Wing nsf
Chipped
1 To 5

15: Bumper Front
Poor Previous Repair
Poor Paint

16: Bonnet
Chipped
1 To 5

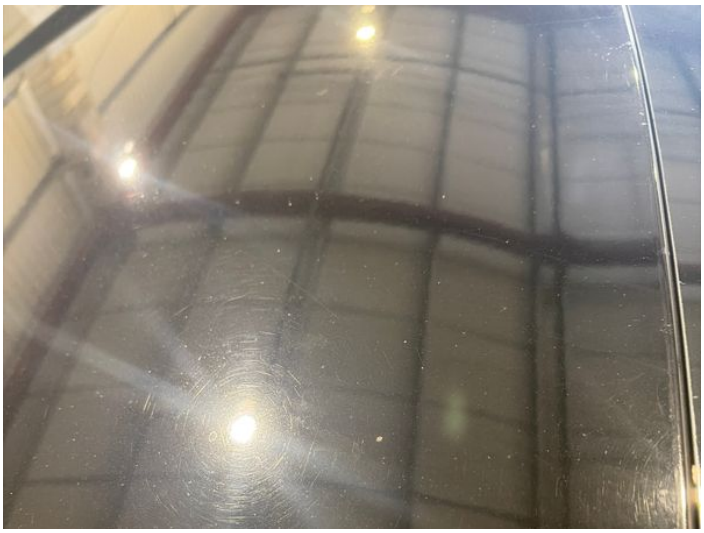
17: Screen Front
Chipped
UpTo 10mm

18: Roof
Chipped
1 To 5
