46 Brampton Road
Eastbourne
BN22 9BN
01323 520295 | no-reply@ebca.co.uk

VEHICLE INSPECTION REPORT

GL14EOZ

Audi A4 2.0 TDI 150 S Line 4dr

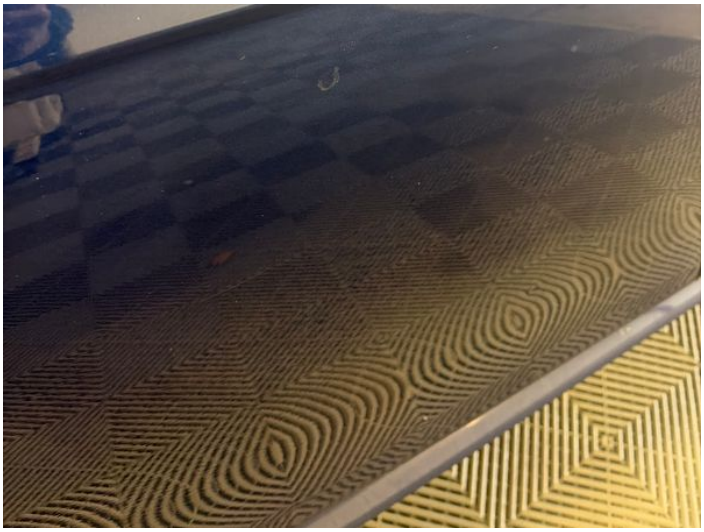
Damage Photos

1: Wheel osf
Scratched
Over 50mm

2: Wing osf
Chipped
1 To 5

3: Door osf
Chipped
Edge Chip

4: Door osr
Chipped
1 To 5

5: Door osr
Chipped
Edge Chip

6: Wheel osr
Scratched
Over 50mm

7: Bumper Rear
Dented
With Paint Damage

8: Lamp osr
Broken
Replace

9: Door nsr
Chipped
1 To 5

10: Wing nsf
Dented
Over 30mm

11: Wheel nsf
Scratched
Over 50mm

12: Bumper Front
Poor Previous Repair
Paint Flake

13: Bonnet
Chipped
Multiple Chips

14: Screen Front
Chipped
UpTo 10mm

15: Sunvisor ns
Broken
Replace
