46 Brampton Road
Eastbourne
BN22 9BN
01323 520295 | no-reply@ebca.co.uk

VEHICLE INSPECTION REPORT

GU19KPY

Toyota RAV4 2.5 VVT-i Hybrid Design 5dr CVT 2WD

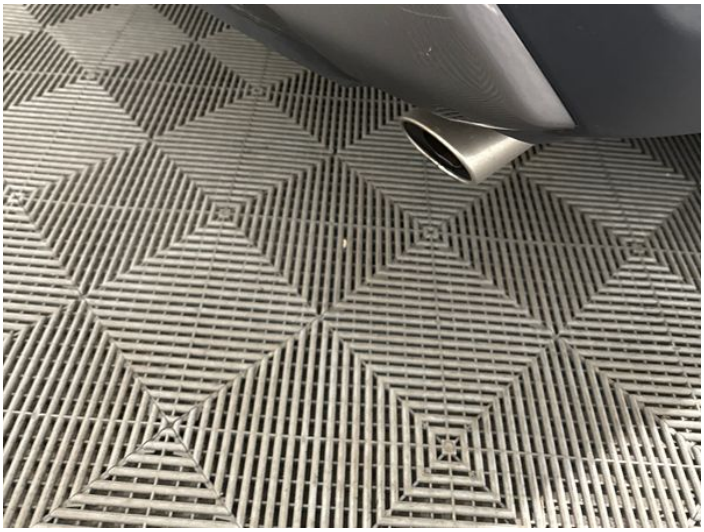
1: Bonnet
Chipped
1 To 5

2: Bumper Front
Chipped
1 To 5

3: Wheel nsf
Scratched
Over 50mm

4: Door Mirror Assy osf
Scratched (Painted)
UpTo 25mm Thru Paint

5: Door nsf
Poor Previous Repair
Rippled UpTo 30%

6: Door nsr
Dented
Over 30mm

7: Wheel nsr
Scratched
Up To 50mm

8: Bumper Rear
Scratched
25 to 100mm Thru Paint

9: Boot Lid
Dented
Over 30mm

10: Bumper Rear Moulding
Scratched (Painted)
Over 25mm Thru Paint

11: Boot Lid
Scratched
Over 25mm Thru Paint

12: Qtr Panel osr
Dented
Between 10mm + 30mm

13: Door osr
Chipped
Edge Chip

14: Handle Outer osf
Scratched (Painted)
UpTo 25mm Thru Paint

15: Door osf
Chipped
Edge Chip

16: Wheel osf
Scratched
Up To 50mm

17: Roof
Chipped
Edge Chip
