VEHICLE INSPECTION REPORT

GR21HDJ

BMW X3 xDrive30d MHT M Sport 5dr Auto

nama GRADE 2

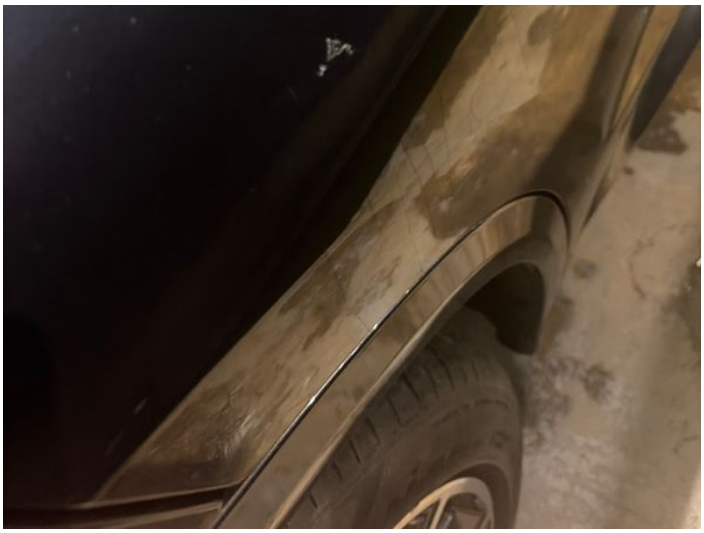
1: Door osf
Chipped
Edge Chip

2: Door osr
Scratched
UpTo 25mm Thru Paint

3: Wheel osr
Scratched
Up To 50mm

4: Qtr Panel osr
Scratched
UpTo 25mm Thru Paint

5: Bumper Rear
Scratched
25 to 100mm Thru Paint

6: Door nsr
Dented
Between 10mm + 30mm

7: Wing nsf
Chipped
1 To 5

8: Bumper Front
Scratched
25 to 100mm Thru Paint

9: Bonnet
Chipped
1 To 5

10: Screen Front
Chipped
UpTo 10mm

11: Door osr
Dented
Between 10mm + 30mm
