# VEHICLE INSPECTION REPORT

**MW22AOL**

## Volkswagen Tiguan Allspace 2.0 TDI R-Line 5dr DSG

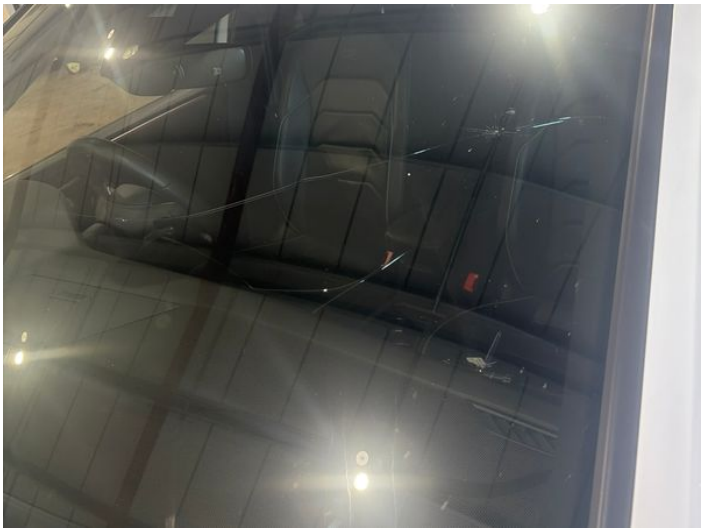
1: Wheel osf
Scratched
Over 50mm

2: Door osf
Chipped
1 To 5

3: Door osf
Dented
Between 10mm + 30mm

4: Wheel osr
Corroded
Light

5: Bumper Rear
Chipped
Multiple Chips

6: Wheel nsr
Corroded
Light

7: Door Mirror Assy nsf
Broken
Replace

8: Wheel nsf
Scratched
Over 50mm

9: Bumper Front
Poor Previous Repair
Paint Flake

10: Screen Front
Cracked
Replace

11: Tyre nsf
Damaged
Replace
