VEHICLE INSPECTION REPORT

GV17UDE

Kia Sportage 2.0 CRDi KX-3 5dr

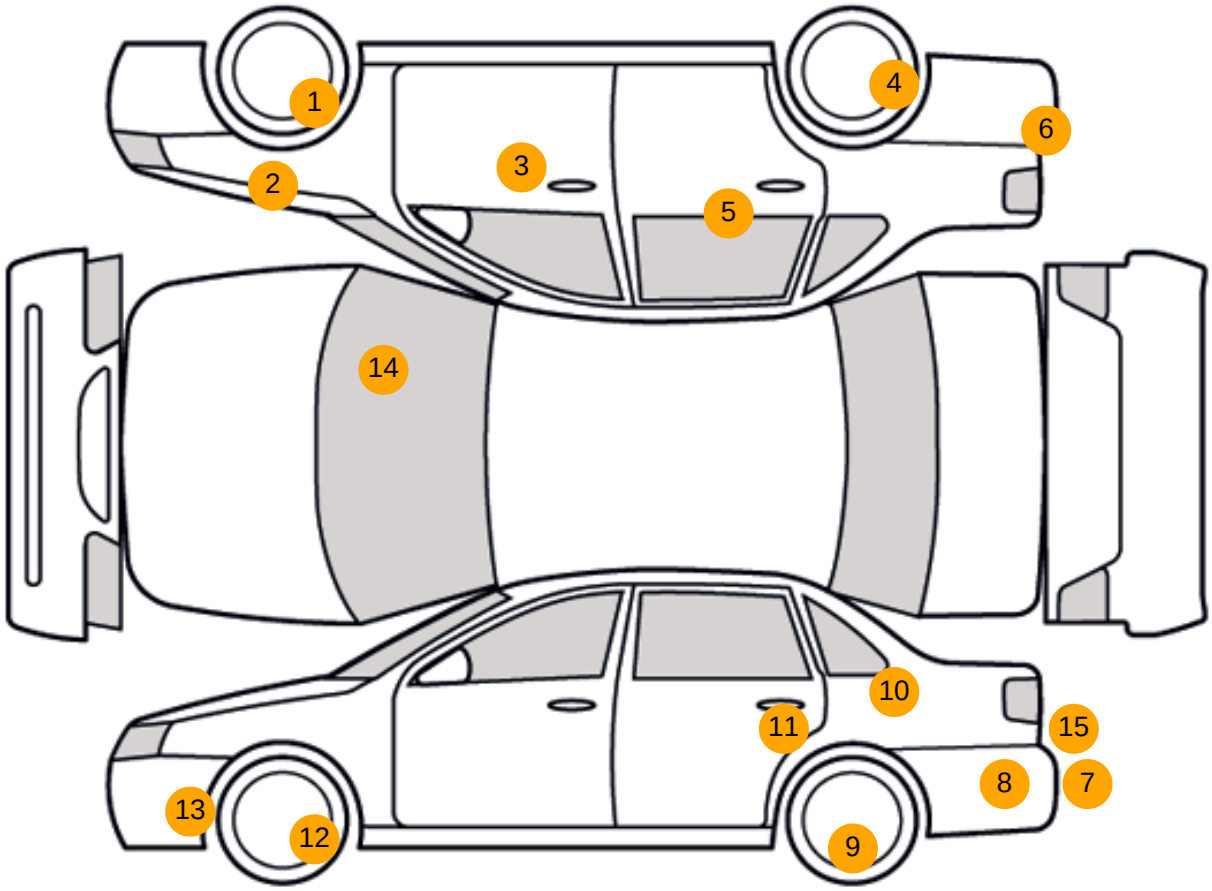
1: Wheel osf
Corroded
Light

2: Wing osf
Chipped
1 To 5

3: Door osf
Chipped
1 To 5

4: Wheel osr
Corroded
Light

5: Door osr
Dented
Over 30mm

6: Bumper Rear
Chipped
Multiple Chips

7: Bumper Rear Moulding
Scuffed (Unpainted)
UpTo 100mm

8: Bumper Rear
Scratched
Up To 25mm Thru Paint

9: Wheel nsr
Corroded
Light

10: Qtr Panel nsr
Scratched
Over 25mm Thru Paint

11: Door nsr
Dented
Between 10mm + 30mm

12: Wheel nsf
Corroded
Light

13: Bumper Front
Scratched
25 to 100mm Thru Paint

14: Screen Front
Chipped
UpTo 10mm

15: Lamp nsr
Broken
Replace
