VEHICLE INSPECTION REPORT

LS21GXP

Abarth 595 1.4 T-Jet 145 3dr

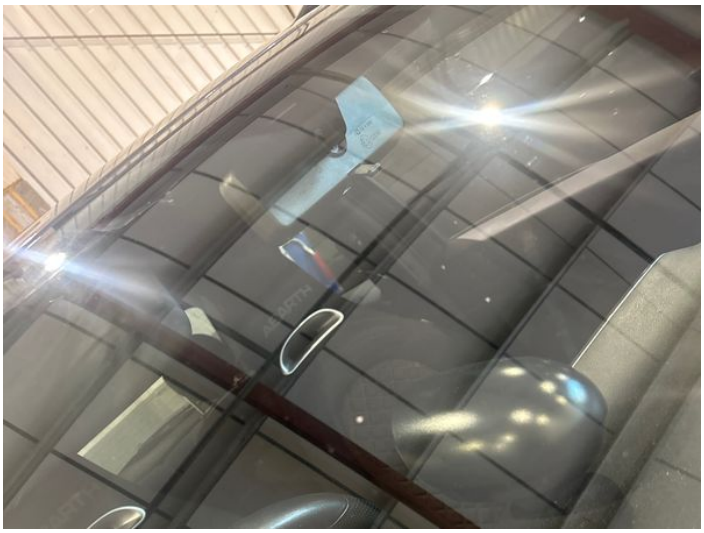
Damage Photos

1: Wheel osf
Scratched
Over 50mm

2: Wing osf
Chipped
1 To 5

3: Door osf
Chipped
1 To 5

4: Wheel osr
Scratched
Over 50mm

5: Fog Lamp osr
Broken
Replace

6: Bumper Rear
Chipped
1 To 5

7: Wheel nsr
Scratched
Over 50mm

8: Door nsf
Chipped
Edge Chip

9: Wheel nsf
Scratched
Over 50mm

10: Bumper Front
Scratched
25 to 100mm Thru Paint

11: Bonnet
Chipped
1 To 5

12: Screen Front
Chipped
UpTo 10mm
