VEHICLE INSPECTION REPORT

GU64EKF

Vauxhall Mokka 1.7 CDTi Exclusiv 5dr

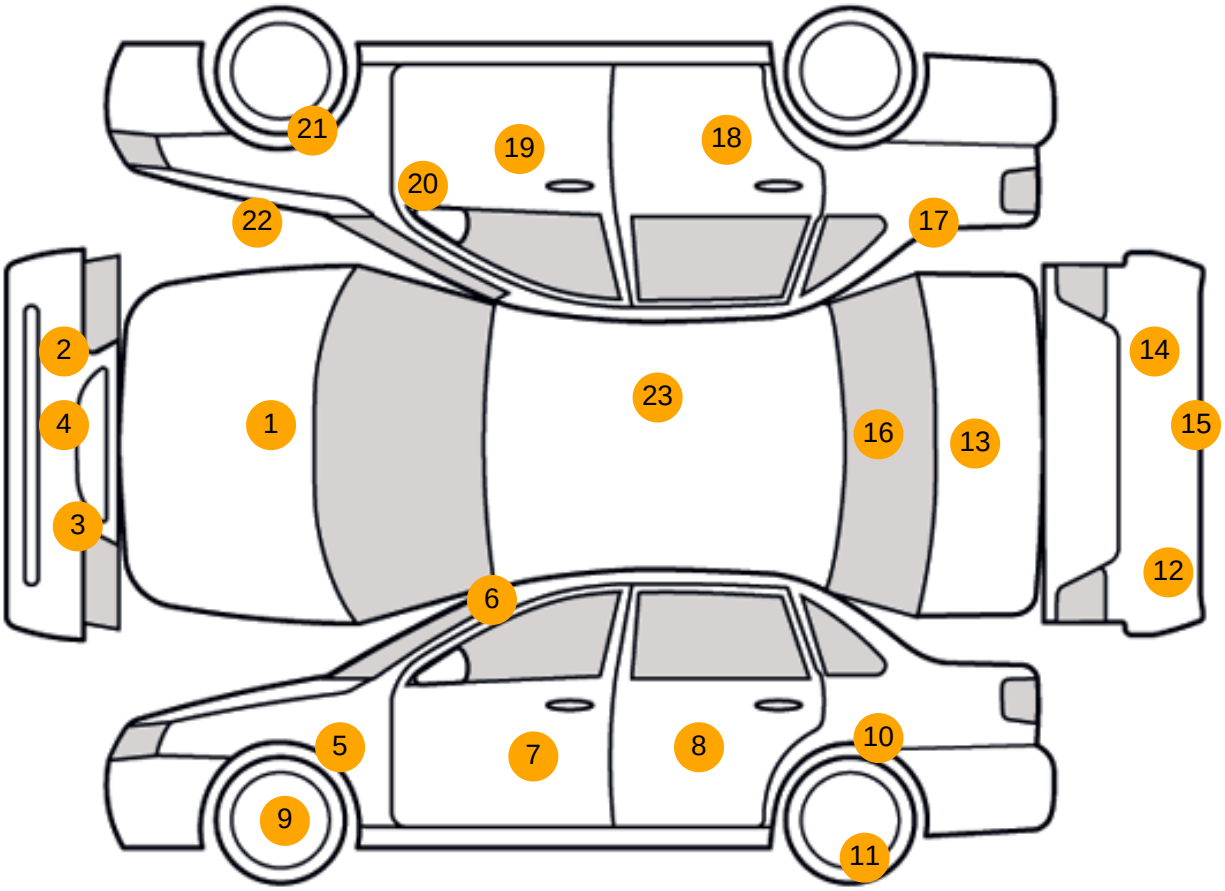
Damage Photos

1: Bonnet
Scratched
Over 25mm Thru Paint

2: Bumper Front
Scratched
25 to 100mm Thru Paint

3: Bumper Front
Scratched
25 to 100mm Thru Paint

4: Bumper Front Moulding
Scuffed (Unpainted)
Over 100mm

5: Wing nsf
Chipped
1 To 5

6: Bumper Front
Insecure
Action Required

7: A Post ns
Chipped
1 To 5

8: Door nsf
Dented
With Paint Damage

9: Door nsr
Poor Previous Repair
Rippled UpTo 30%

10: Wheel nsf
Scratched
Over 50mm

11: Qtr Panel nsr
Scratched
UpTo 25mm Thru Paint

12: Wheel nsr
Scratched
Over 50mm

13: Bumper Rear
Scratched
25 to 100mm Thru Paint

14: Boot Lid
Scratched
UpTo 25mm Thru Paint

15: Bumper Rear
Scratched
25 to 100mm Thru Paint
