VEHICLE INSPECTION REPORT

GU13DHP

Volkswagen Tiguan 2.0 TDi BlueMotion Tech SE 5dr DSG

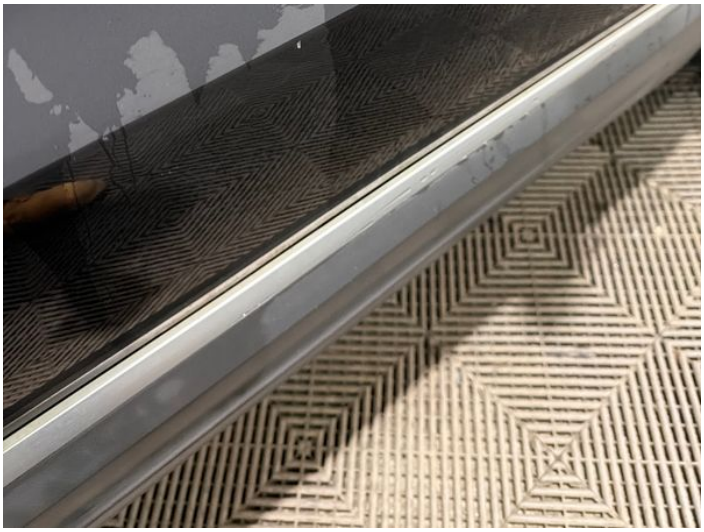
5: Wheel nsf
Scratched
Up To 50mm

6: Door nsf
Chipped
Edge Chip

7: Door nsr
Dented
With Paint Damage

8: Door Moulding nsr
Scuffed (Unpainted)
Over 100mm

9: Qtr Panel Arch Extension ns
Scuffed (Unpainted)
Over 100mm

10: Bumper Rear
Scratched
25 to 100mm Thru Paint

11: Bumper Rear
Scratched
25 to 100mm Thru Paint

12: Boot Lid
Scratched
UpTo 25mm Thru Paint
