VEHICLE INSPECTION REPORT

PL16PXS

Hyundai Santa Fe 2.2 CRDi Blue Drive Wiggins Ed 5dr Auto [7 Seats]

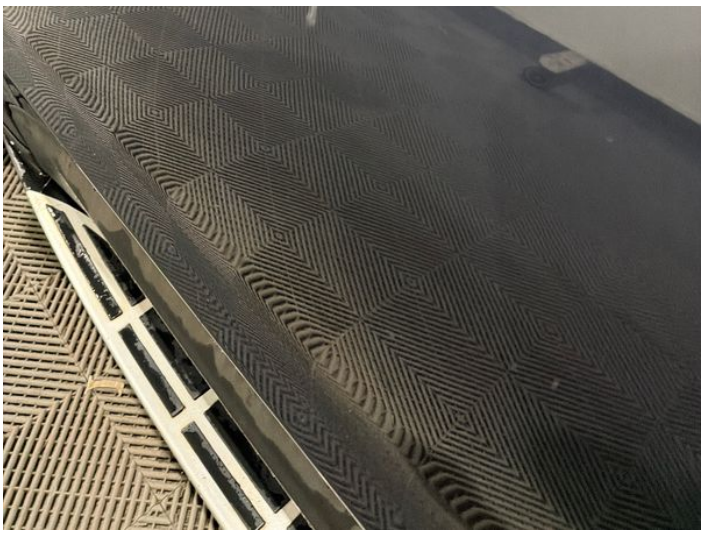
1: Bonnet
Chipped
Multiple Chips

2: Bumper Front
Scratched
25 to 100mm Thru Paint

3: Bumper Front Moulding
Broken
Replace

4: Bumper Front
Scratched
25 to 100mm Thru Paint

5: Wing nsf
Chipped
1 To 5

6: Wheel nsf
Scratched
Over 50mm

7: Door Mirror Assy nsf
Broken
Replace

8: Door nsf
Scratched
UpTo 25mm Thru Paint

9: Door nsr
Scratched
Over 25mm Thru Paint

10: Wheel nsr
Scratched
Over 50mm

11: Door nsr
Dented
Between 10mm + 30mm

12: Qtr Panel nsr
Dented
With Paint Damage

13: Bumper Rear
Dented
With Paint Damage

14: Wheel osr
Scratched
Over 50mm

15: Door osr
Chipped
1 To 5

16: Door osf
Dented
Between 10mm + 30mm

17: Door osf
Chipped
Edge Chip

18: Door osf
Scratched
UpTo 25mm Thru Paint

19: Wing osf
Chipped
1 To 5

20: Wheel osf
Scratched
Over 50mm
