VEHICLE INSPECTION REPORT

HG18CSO

Audi A3 1.5 TFSI Black Edition 4dr

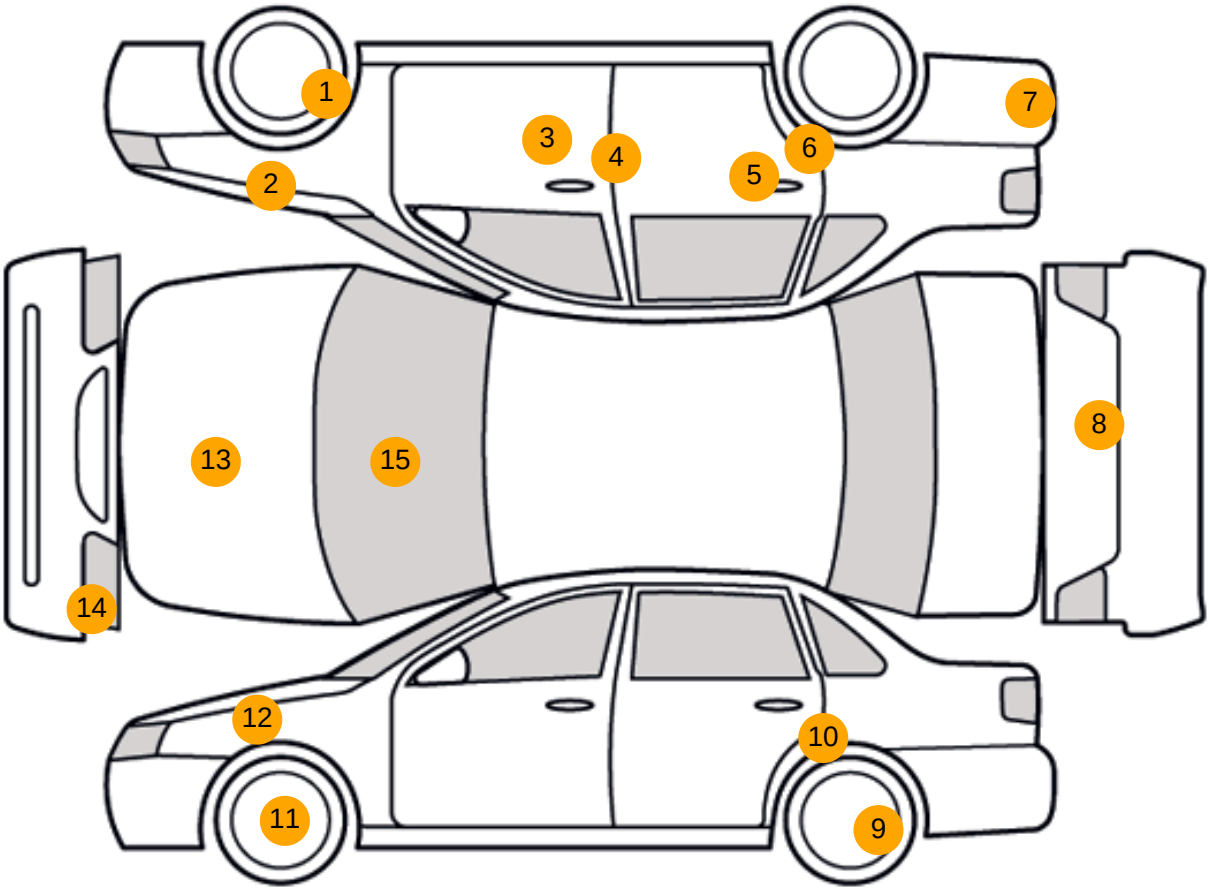
Condition Check

Engine Runs	OK	Gearbox 1st and Reverse Test	OK
Brakes	OK	Clutch Slip Test from Static	OK
Turbo Boosting	OK	Gearbox Static Gear Selection (engine running)	OK
Parking Brake	OK	No Excessive Smoking	OK
EML light illuminated	OK	Oil warning light illuminated	OK
Airbag light illuminated	OK	Service indicator light illuminated	Fault
ABS light illuminated	OK		
Windows	OK	Radio	OK
Sat nav	OK	Steering	OK
