VEHICLE INSPECTION REPORT

NV72CLU

MG Mg Zs EXCLUSIVE T-GDI

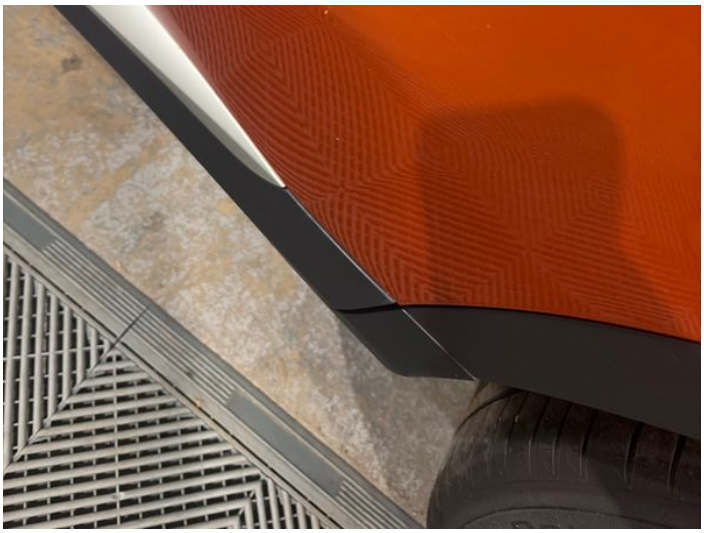
1: Wing osf
Chipped
1 To 5

2: Door osf
Chipped
Edge Chip

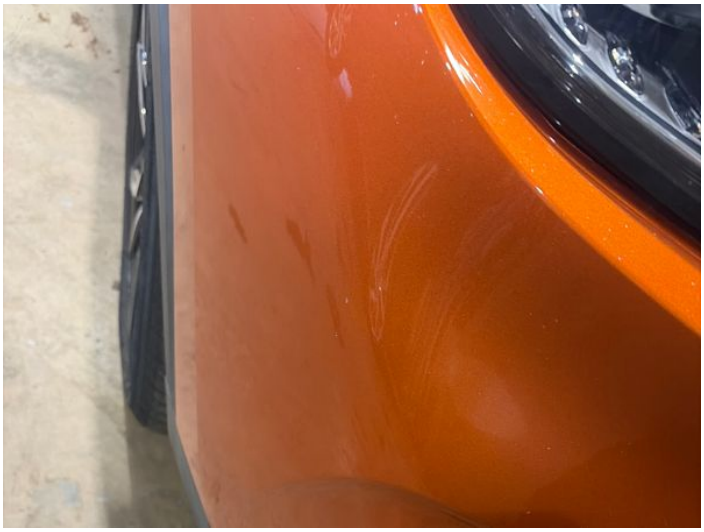
3: Door osr
Chipped
1 To 5

4: Door osr
Chipped
Edge Chip

5: Door nsr
Chipped
Edge Chip
