VEHICLE INSPECTION REPORT

YG61LVR

Ford Fiesta 1.6 TDCi [95] Titanium 5dr

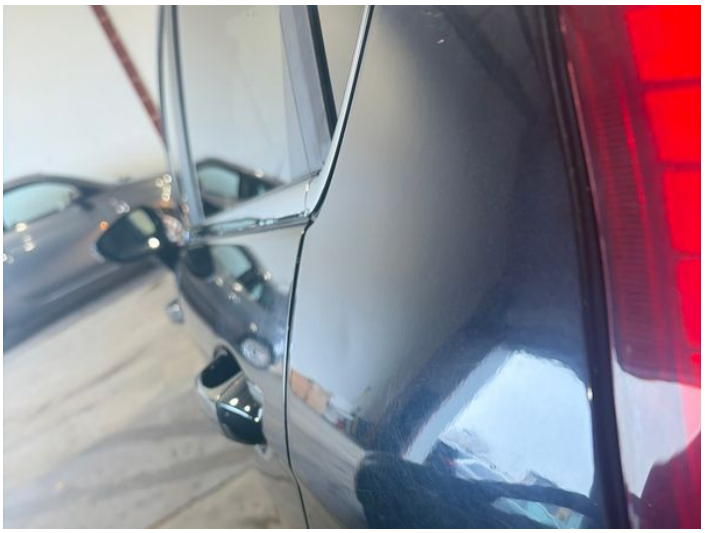
1: Wheel osf
Scratched
Over 50mm

2: Wing osf
Chipped
1 To 5

3: Door osf
Chipped
1 To 5

4: Door osf
Chipped
Edge Chip

5: Door osr
Chipped
1 To 5

6: Door osr
Chipped
Edge Chip

7: Qtr Panel osr
Dented
2 Or Less UpTo 10mm

8: Qtr Panel osr
Chipped
1 To 5
