VEHICLE INSPECTION REPORT

BL19XWO

Hyundai Tucson 1.6 GDi SE Nav 5dr 2WD

Eastbourne Car Auctions

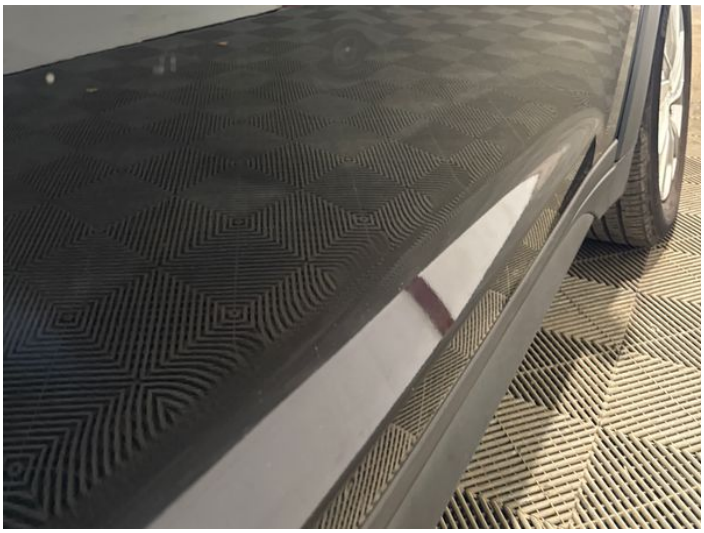
1: Bonnet
Scratched
Over 25mm Thru Paint

2: Bumper Front
Chipped
Multiple Chips

3: Wheel nsf
Scratched
Over 50mm

4: Wing nsf
Scratched
Over 25mm Thru Paint

5: Flasher Side Repeater ns
Broken
Replace

6: Door Mirror Assy nsf
Scratched (Painted)
UpTo 25mm Thru Paint

7: A Post ns
Scratched
Over 25mm Thru Paint

8: Door nsf
Scratched
Over 25mm Thru Paint

9: Door nsr
Scratched
Over 25mm Thru Paint

10: Wheel nsr
Scratched
Over 50mm

11: Qtr Panel nsr
Scratched
Over 25mm Thru Paint

12: Boot Lid
Scratched
Over 25mm Thru Paint

13: Bumper Rear
Scratched
25 to 100mm Thru Paint
