VEHICLE INSPECTION REPORT

OIG4849

Vauxhall Corsa 1.4T [100] Limited Edition 3dr

Condition Check

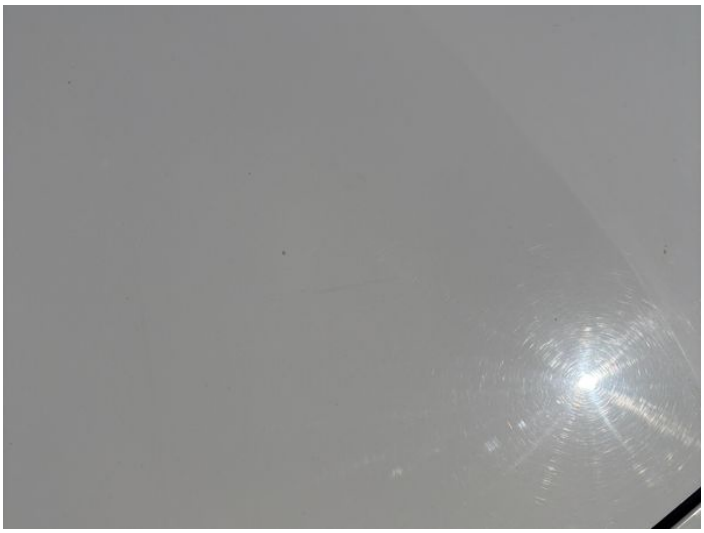
1: Bonnet
Chipped
1 To 5

2: Bumper Front
Poor Previous Repair
Poor Paint

3: Wing nsf
Chipped
1 To 5

4: Wheel nsf
Scratched
Over 50mm

5: Door nsf
Scratched
Over 25mm Thru Paint

6: Sill Panel Trim ns
Broken
Replace

7: Wheel nsr
Scratched
Over 50mm

8: Bumper Rear
Poor Previous Repair
Poor Paint

9: Bumper Rear
Dented
With Paint Damage

10: Qtr Panel nsr
Poor Previous Repair
Rippled UpTo 30%

11: Door nsf
Dented
Over 30mm

12: Qtr Panel osr
Poor Previous Repair
Rippled UpTo 30%

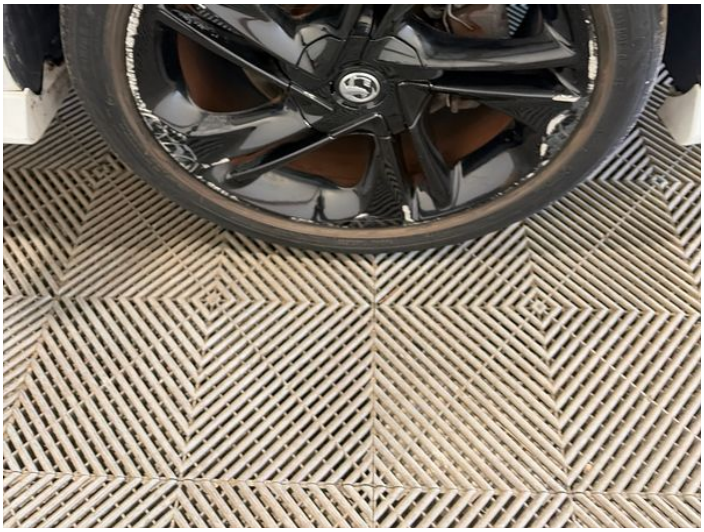
13: Wheel osr
Scratched
Up To 50mm

14: Door osf
Dented
With Paint Damage

15: Wing osf
Dented
Over 30mm

16: Wheel osf
Scratched
Over 50mm

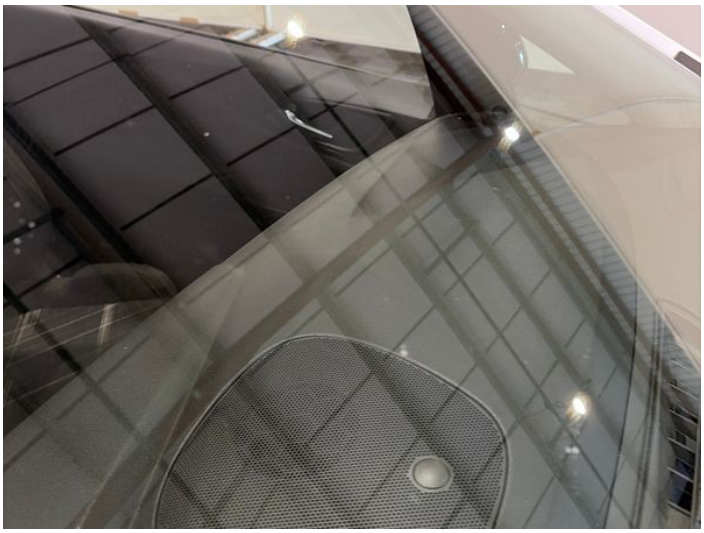
17: Screen Front
Chipped
UpTo 10mm

18: Roof
Scratched
Over 25mm Thru Paint

19: Seat Base Cover osf
Torn
Over 3mm

20: Tailgate
Cracked
Replace
