VEHICLE INSPECTION REPORT

RE64EKJ

Honda CR-V 2.0 i-VTEC EX 5dr

Condition Check

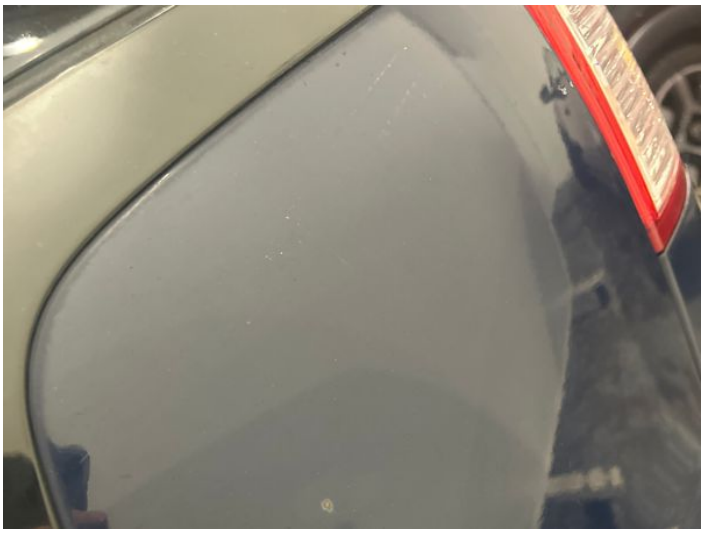
1: Wheel osf
Corroded
Light

2: Wing osf
Chipped
1 To 5

3: A Post os
Chipped
1 To 5

4: Door osf
Chipped
1 To 5

5: Door osf
Chipped
Edge Chip

6: Door osr
Scratched
Over 25mm Thru Paint

7: Wheel osr
Corroded
Light

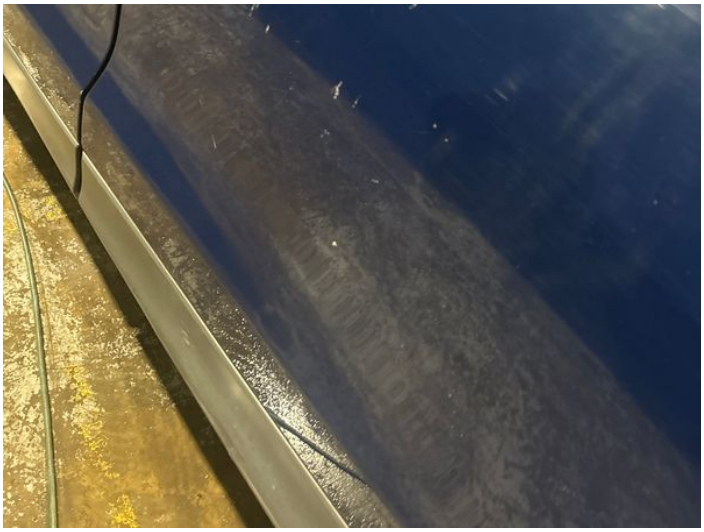
8: Qtr Panel osr
Scratched
UpTo 25mm Thru Paint

9: Bumper Rear
Scratched
Over 100mm Thru Paint

10: Lamp nsr
Broken
Replace

11: Tailgate
Chipped
1 To 5

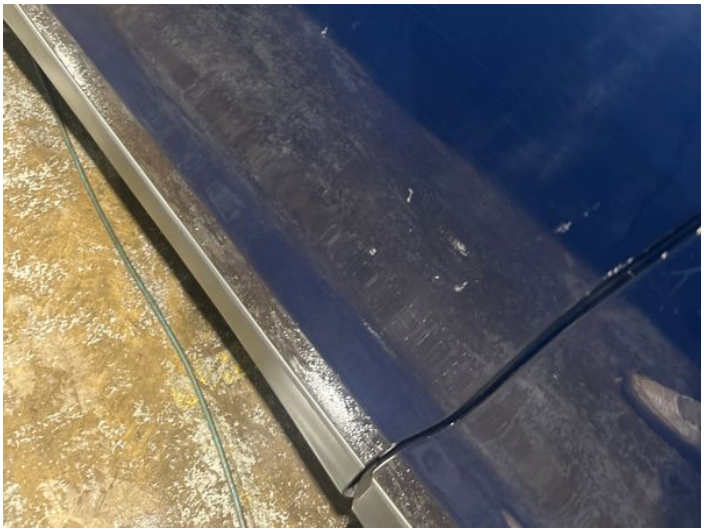
12: Qtr Panel nsr
Dented
Between 10mm + 30mm

13: Qtr Panel nsr
Chipped
1 To 5

14: Wheel nsr
Corroded
Light

15: Door nsr
Chipped
Multiple Chips
