VEHICLE INSPECTION REPORT

AO59FYB

Vauxhall Astra 1.4i 16V Active 5dr

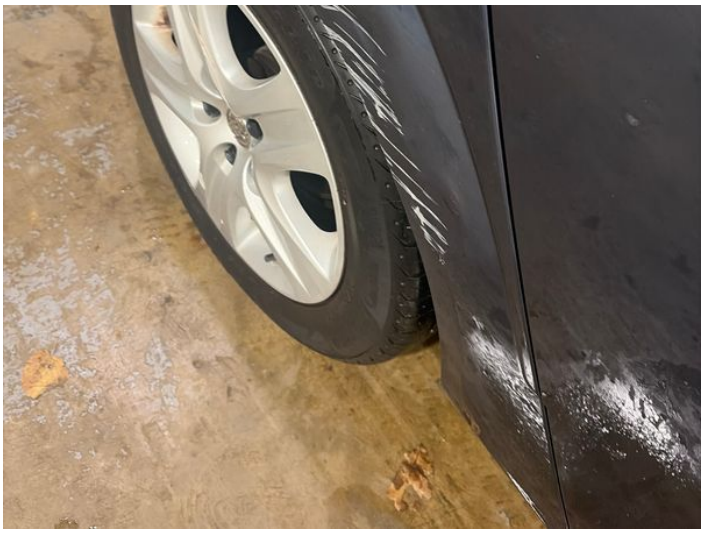
1: Wing osf
Scratched
Over 25mm Thru Paint

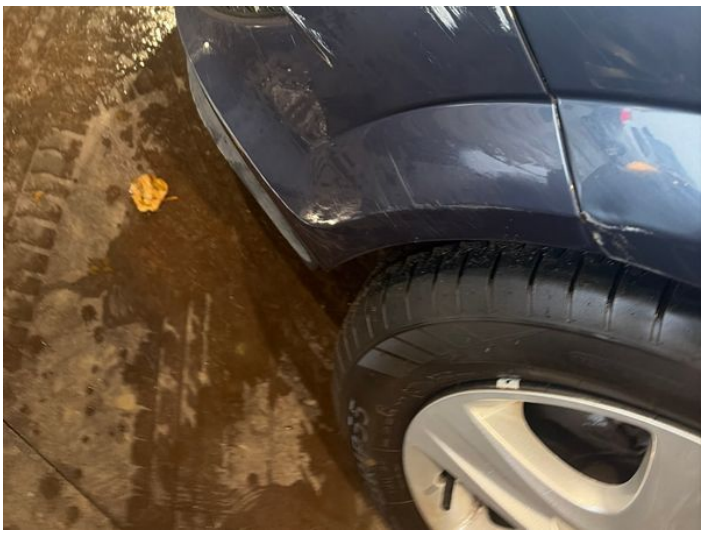
5: Qtr Panel osr
Dented
With Paint Damage

6: Bumper Rear
Scratched
Over 100mm Thru Paint

7: Qtr Panel nsr
Scratched
Over 25mm Thru Paint

8: Sill ns
Dented
With Paint Damage

9: Door nsr
Chipped
1 To 5
