VEHICLE INSPECTION REPORT

OV16KCA

Peugeot 208 1.2 PureTech XS-White 5dr

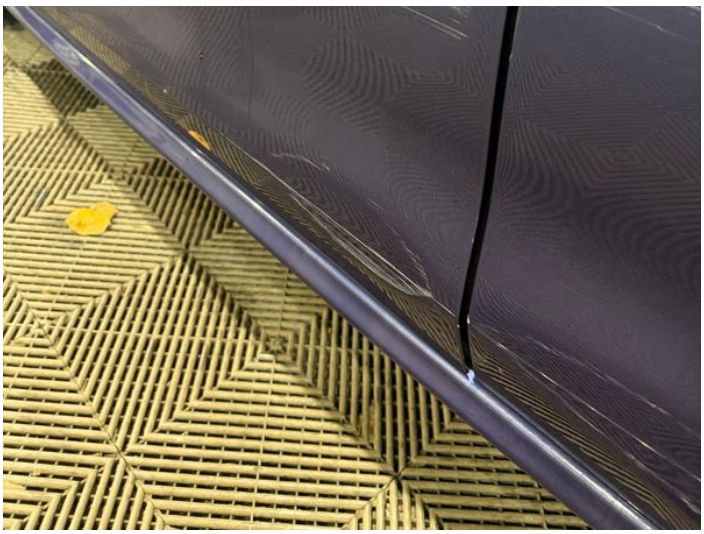
4: Wheel nsf
Scratched
Over 50mm

5: Wing nsf
Chipped
1 To 5

6: Screen Front
Scratched
Over 30mm

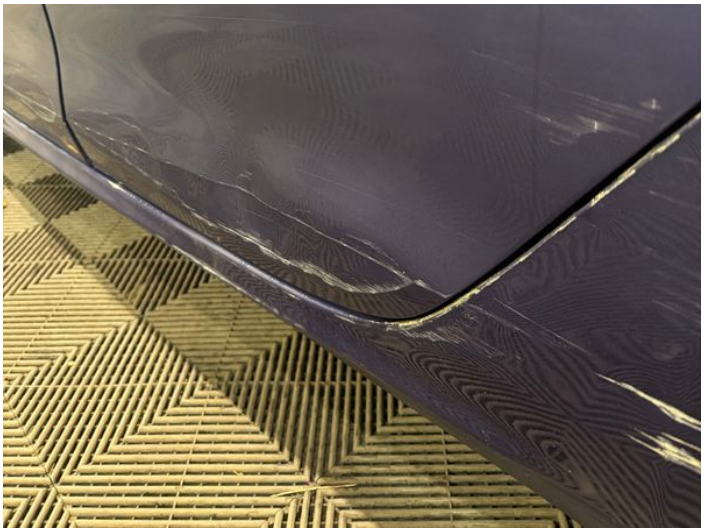
7: Door Mirror Assy osf
Scratched (Painted)
UpTo 25mm Thru Paint

8: Door nsf
Dented
With Paint Damage

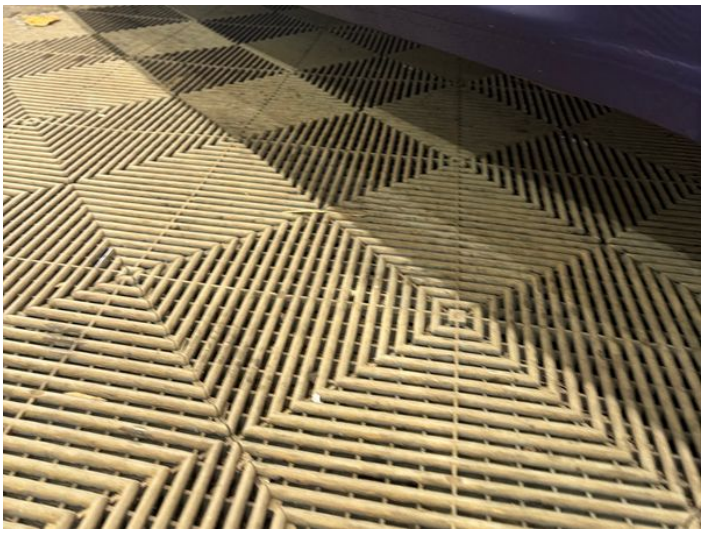
9: Door nsr
Dented
With Paint Damage
