VEHICLE INSPECTION REPORT

KT67NNV

Peugeot 3008 1.6 BlueHDi 120 Allure 5dr EAT6

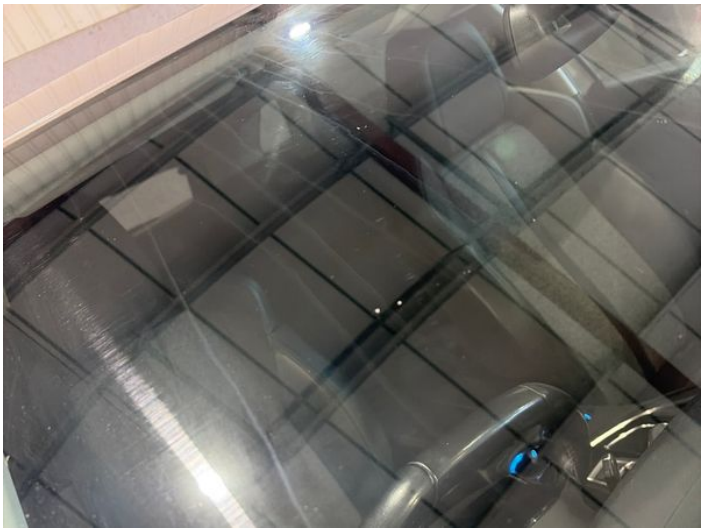
1: Wheel osf
Corroded
Light

2: Door osr
Chipped
1 To 5

3: Wheel osr
Corroded
Light

4: Door osr
Dented
2 Or Less UpTo 10mm

5: Wheel nsr
Corroded
Light

6: Door nsr
Dented
With Paint Damage

7: Door nsf
Scratched
Over 25mm Thru Paint

8: Bumper Front
Chipped
1 To 5

9: Screen Front
Chipped
UpTo 10mm
