VEHICLE INSPECTION REPORT

OE19RNV

Peugeot 5008 1.6 PureTech 180 GT Line Premium 5dr EAT8

nama GRADE 3

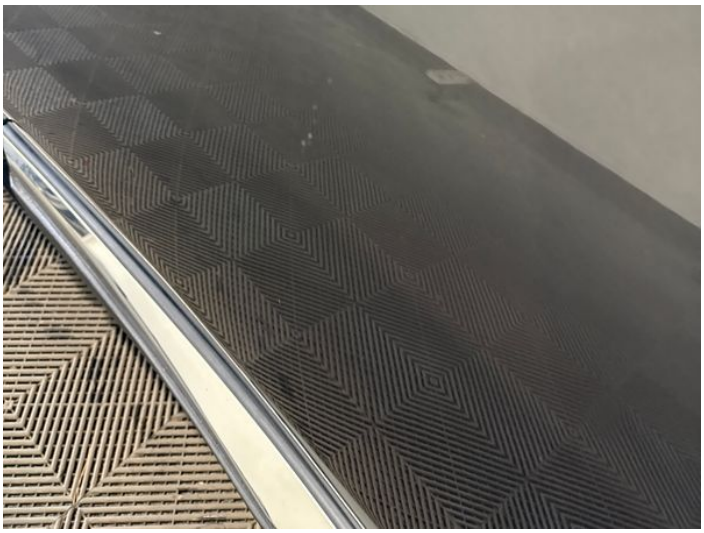
1: Bonnet
Chipped
1 To 5

2: Bumper Front
Scratched
25 to 100mm Thru Paint
