VEHICLE INSPECTION REPORT

WF64WPW

Peugeot 308 1.6 e-HDi 115 Feline 5dr

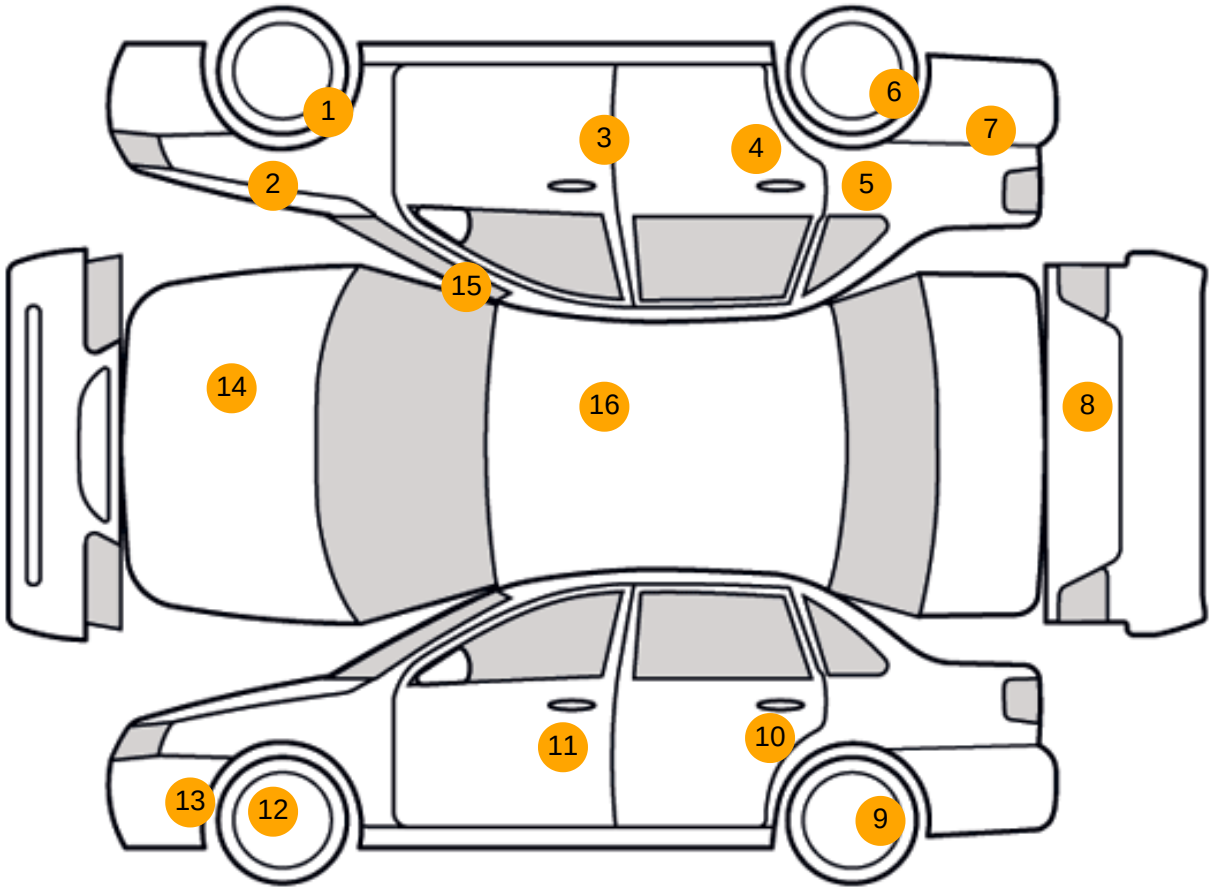
Condition Check

1: Wheel osf
Scratched
Over 50mm

2: Wing osf
Chipped
1 To 5

3: Door osf
Chipped
Edge Chip

4: Door osr
Chipped
1 To 5

5: Qtr Panel osr
Chipped
1 To 5

6: Wheel osr
Scratched
Over 50mm

7: Bumper Rear
Scratched
Over 100mm Thru Paint

8: Boot Lid
Chipped
1 To 5

9: Wheel nsr
Scratched
Over 50mm

10: Door nsr
Chipped
1 To 5

11: Door nsf
Scratched
Over 25mm Thru Paint

12: Wheel nsf
Scratched
Over 50mm

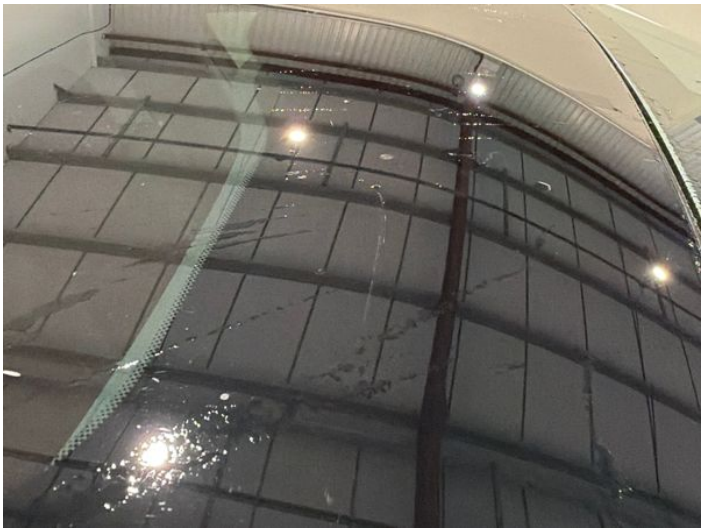
13: Bumper Front
Chipped
Multiple Chips

14: Bonnet
Chipped
1 To 5

15: A Post os
Chipped
1 To 5

16: Glass Roof
Cracked
Replace
