VEHICLE INSPECTION REPORT

PE14YDX

MERCEDES-BENZ B CLASS B180 CDI Sport 5dr

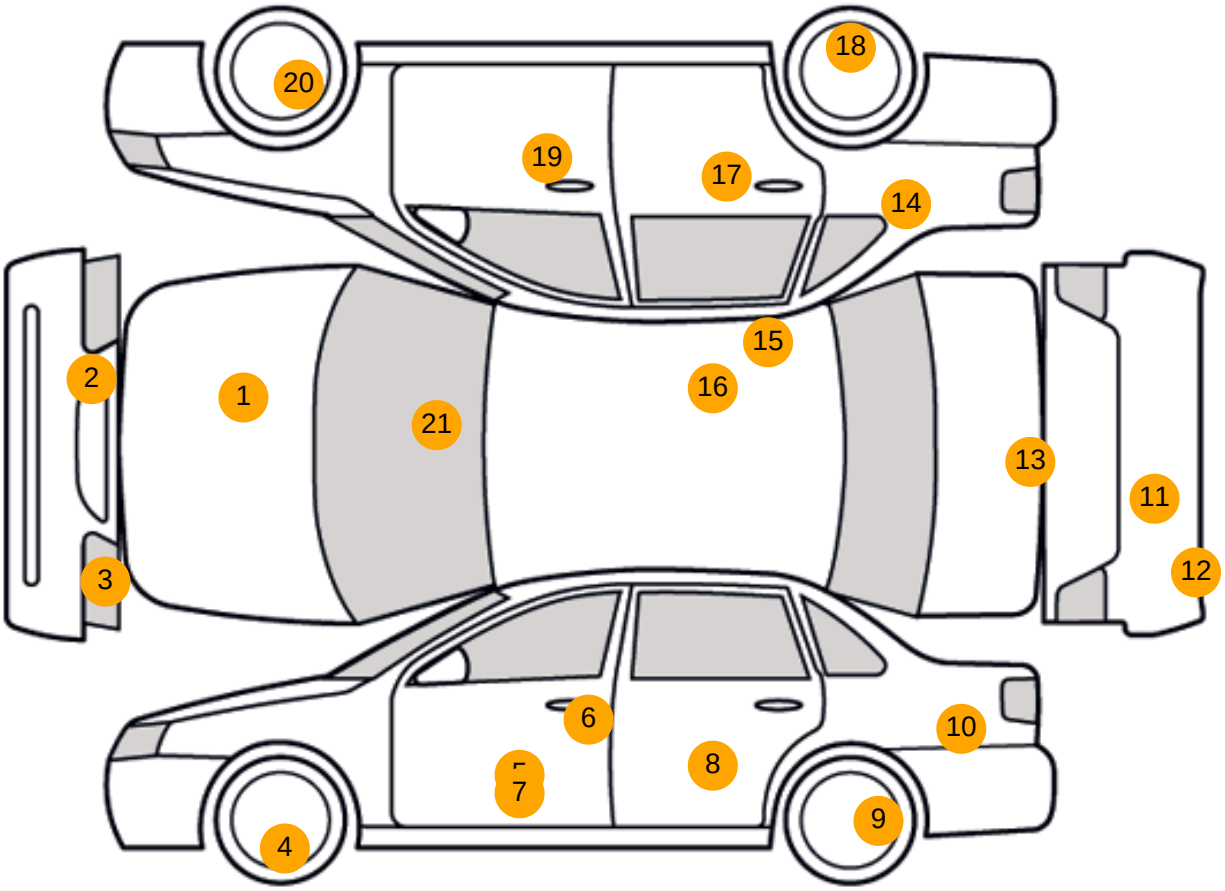
Condition Check

1: Seat Base Cover osf
Scuffed
UpTo 25mm

2: Tyre osf
Damaged
Replace

3: Tyre nsf
Damaged
Replace

4: Tyre nsr
Damaged
Replace

5: Tyre osr
Damaged
Replace

6: Bonnet
Chipped
1 To 5

7: Bumper Front
Scratched
25 to 100mm Thru Paint

8: Bumper Front
Scratched
25 to 100mm Thru Paint

9: Wheel nsf
Scratched
Over 50mm

10: Door nsf
Dented
2 Or Less UpTo 10mm

11: Door nsf
Chipped
Edge Chip

12: Door nsf
Chipped
1 To 5

13: Door nsr
Scratched
Over 25mm Thru Paint

14: Wheel nsr
Scratched
Over 50mm

15: Qtr Panel nsr
Dented
Over 30mm

16: Bumper Rear
Dented
Between 10mm + 30mm

17: Bumper Rear
Poor Previous Repair
Poor Paint

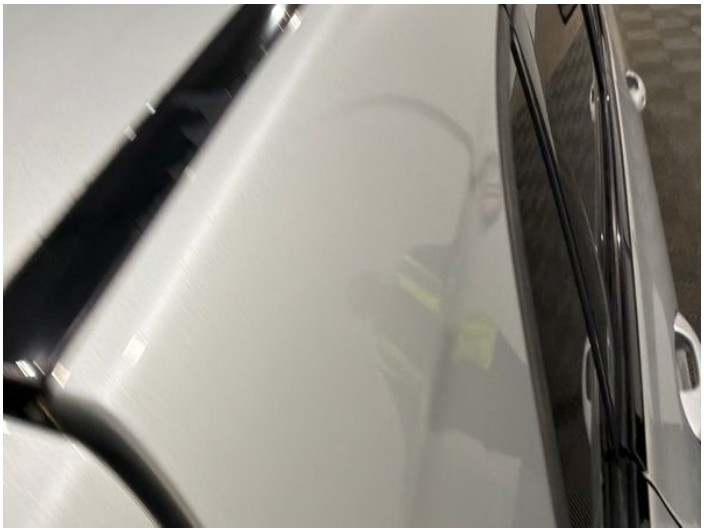
18: Boot Lid
Dented
With Paint Damage

19: Qtr Panel osr
Dented
With Paint Damage

20: C Post os
Dented
Over 30mm

21: Other
N/A
N/A
Roof rails scratched

22: Door osr
Dented
With Paint Damage

23: Wheel osr
Scratched
Over 50mm

24: Door osf
Chipped
Edge Chip

25: Wheel osf
Scratched
Over 50mm

26: Screen Front
Chipped
Over 10mm
