VEHICLE INSPECTION REPORT

HV69OWD

Seat Arona 1.0 TSI 115 FR Sport [EZ] 5dr DSG

nama GRADE 2

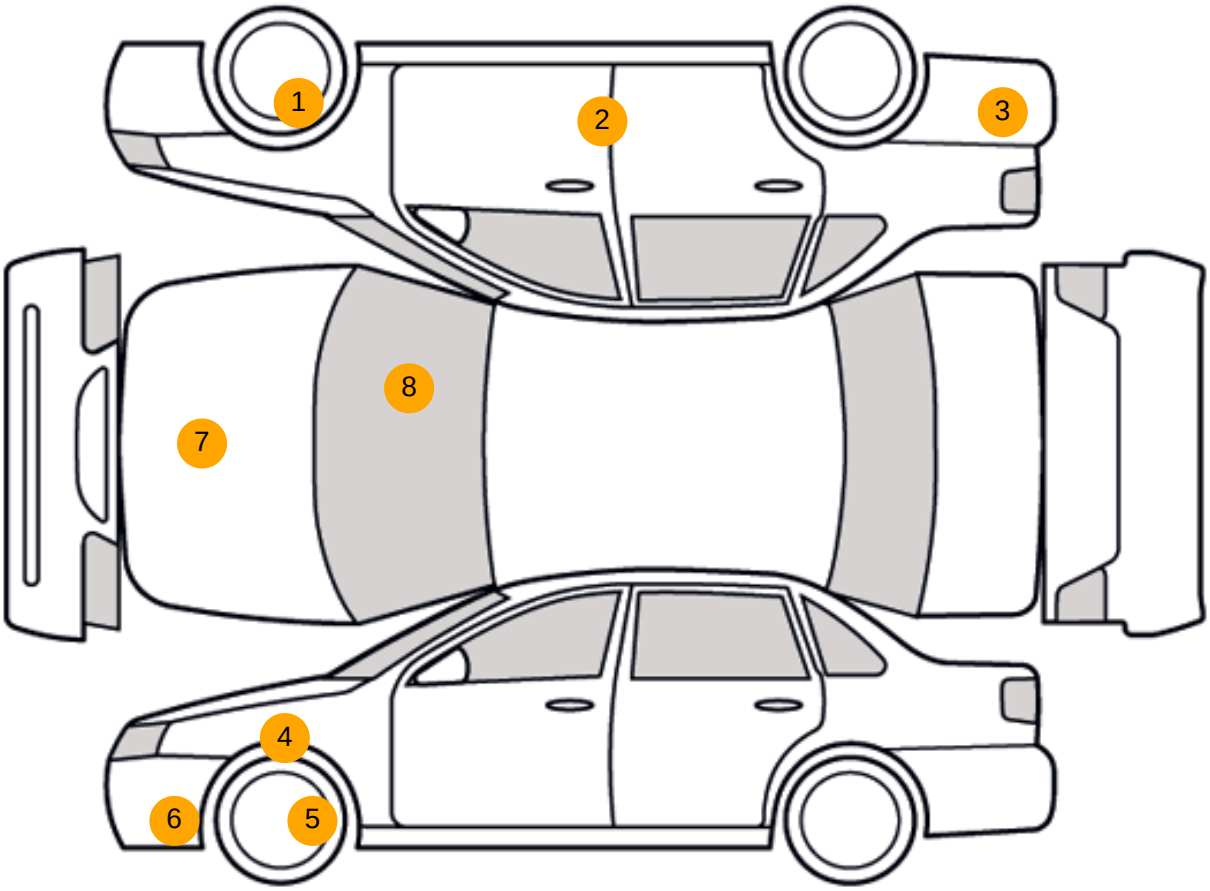
Condition Check

1: Wheel osf
Scratched
Over 50mm

2: Door osf
Chipped
Edge Chip

3: Bumper Rear
Scratched
25 to 100mm Thru Paint

4: Wing nsf
Scratched
Over 25mm Thru Paint

5: Wheel nsf
Scratched
Over 50mm

6: Bumper Front
Scratched
25 to 100mm Thru Paint

7: Bonnet
Chipped
1 To 5

8: Screen Front
Chipped
UpTo 10mm
