VEHICLE INSPECTION REPORT

YD64ZFK

Volvo XC60 D4 [181] SE 5dr AWD

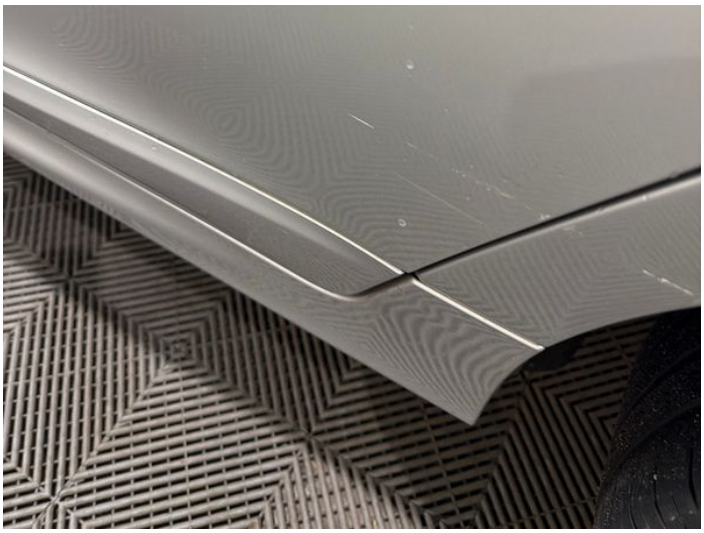
4: Door nsf
Scratched
Over 25mm Thru Paint

5: Door nsr
Scratched
Over 25mm Thru Paint

6: Wheel nsr
Scratched
Over 50mm

7: Qtr Panel nsr
Scratched
Over 25mm Thru Paint

8: Bumper Rear
Scratched
25 to 100mm Thru Paint

9: Roof
Dented
Between 10mm + 30mm

10: Qtr Panel osr
Chipped
1 To 5

11: Wheel osr
Corroded
Light

12: Door osr
Dented
Between 10mm + 30mm

13: Door osr
Scratched
UpTo 25mm Thru Paint

14: Door osf
Dented
Between 10mm + 30mm

15: Wheel osf
Scratched
Over 50mm

16: Wing osf
Chipped
1 To 5
