VEHICLE INSPECTION REPORT

HV66ZTJ

Kia Sportage 1.6 GDi ISG 2 5dr

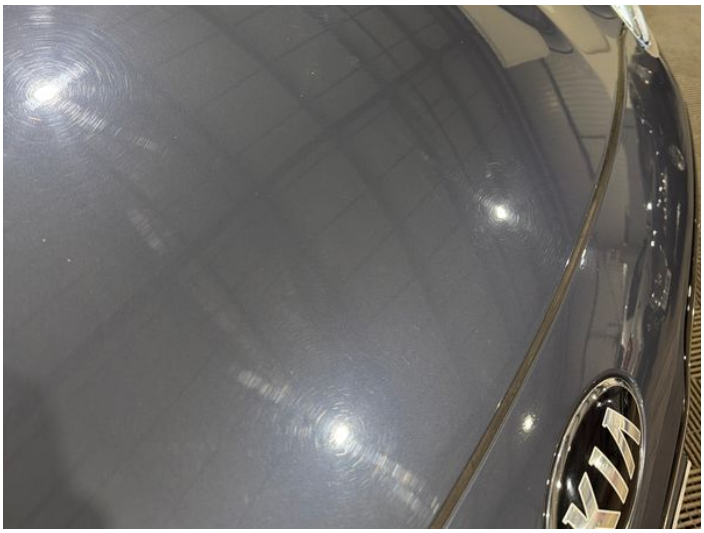
1: Bonnet
Chipped
1 To 5

2: Bumper Front
Scratched
25 to 100mm Thru Paint

3: Bumper Front Moulding
Broken
Replace

4: Bumper Front
Scratched
25 to 100mm Thru Paint

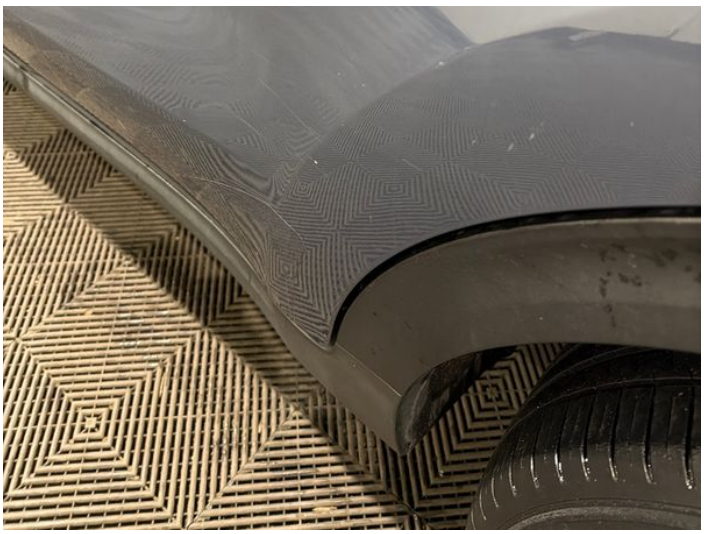
5: Wing nsf
Chipped
1 To 5

6: Wheel nsf
Scratched
Over 50mm

7: Door nsf
Dented
With Paint Damage

8: Door nsr
Chipped
Multiple Chips

9: Qtr Panel nsr
Dented
Between 10mm + 30mm

10: Qtr Panel nsr
Scratched
UpTo 25mm Thru Paint

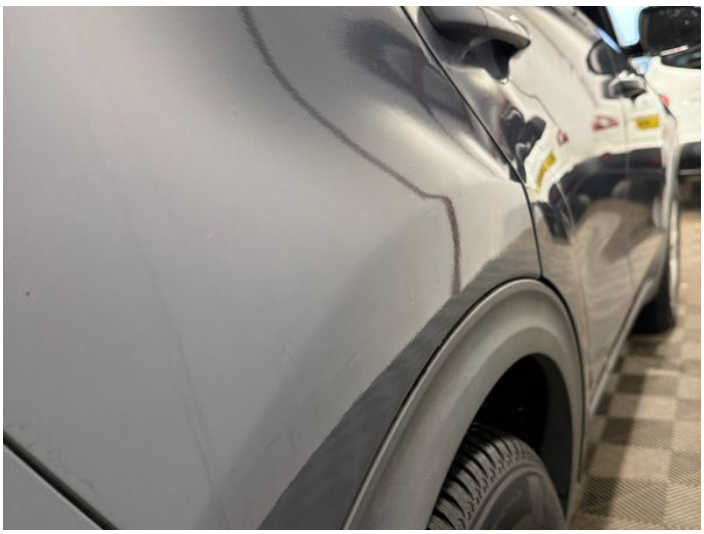
11: Wheel nsr
Scratched
Over 50mm

12: Bumper Rear
Scratched
25 to 100mm Thru Paint

13: Boot Lid
Chipped
1 To 5

14: Qtr Panel osr
Poor Previous Repair
Rippled UpTo 30%

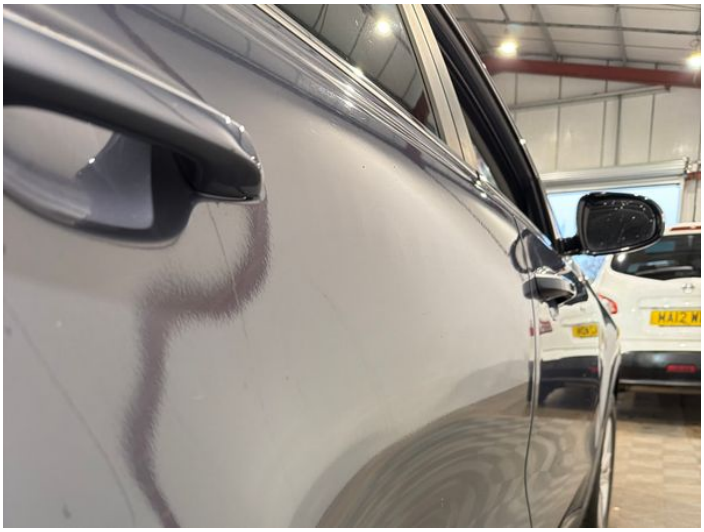
15: Wheel osr
Scratched
Over 50mm

16: Door osr
Poor Previous Repair
Rippled UpTo 30%

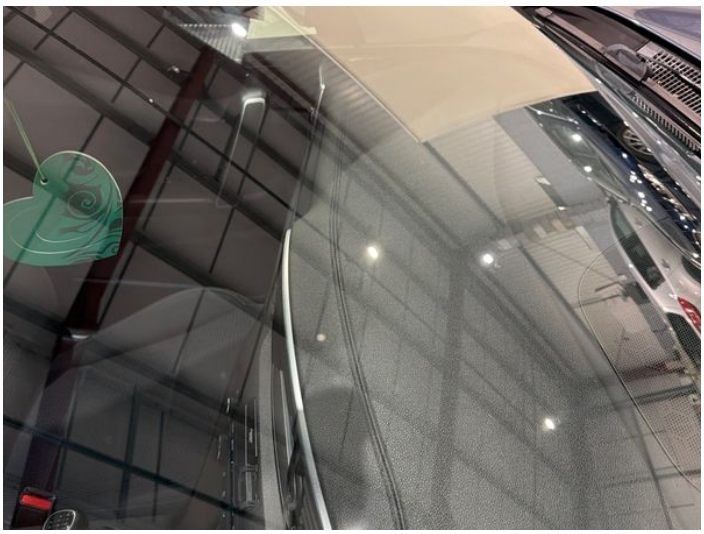
17: Door osf
Scratched
Over 25mm Thru Paint

18: Wing osf
Chipped
1 To 5

19: Wheel osf
Scratched
Over 50mm

20: Screen Front
Chipped
UpTo 10mm
