# VEHICLE INSPECTION REPORT

**GF20HXM**

## Vauxhall Grandland X 1.2 Turbo SRi Nav 5dr

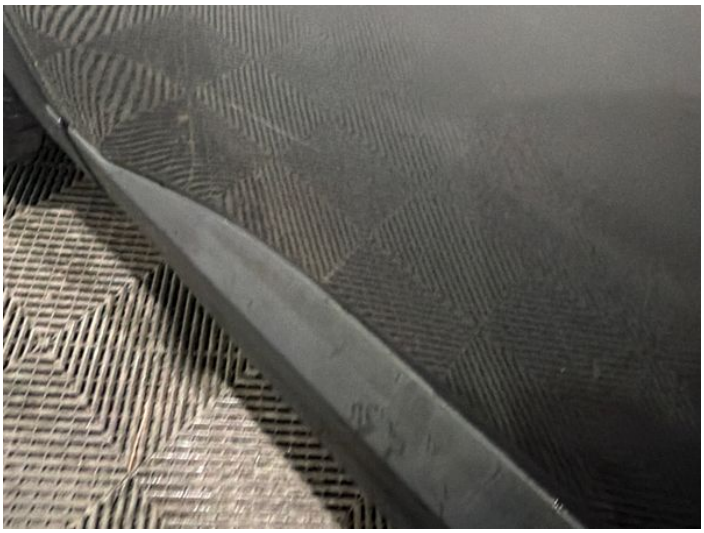
1: Bonnet
Chipped
Multiple Chips

2: Bumper Front
Chipped
1 To 5

3: Bumper Front
Scratched
25 to 100mm Thru Paint

4: Wheel nsf
Scratched
Over 50mm

5: Wing nsf
Scratched
UpTo 25mm Thru Paint

6: Door nsf
Scratched
Over 25mm Thru Paint

7: Door nsr
Chipped
1 To 5

8: Wheel nsr
Scratched
Over 50mm

9: Qtr Panel nsr
Scratched
Over 25mm Thru Paint

10: Boot Lid
Scratched
Over 25mm Thru Paint

11: Bumper Rear
Scratched
25 to 100mm Thru Paint

12: Wheel osr
Scratched
Over 50mm

13: Door nsr
Dented
Between 10mm + 30mm

14: Door osr
Chipped
Edge Chip

15: Door osf
Poor Previous Repair
Rippled UpTo 30%

16: Wheel osf
Scratched
Over 50mm

17: Wing osf
Chipped
1 To 5
