VEHICLE INSPECTION REPORT

GP17LFM

Kia Sportage CRDI GT-LINE S ISG

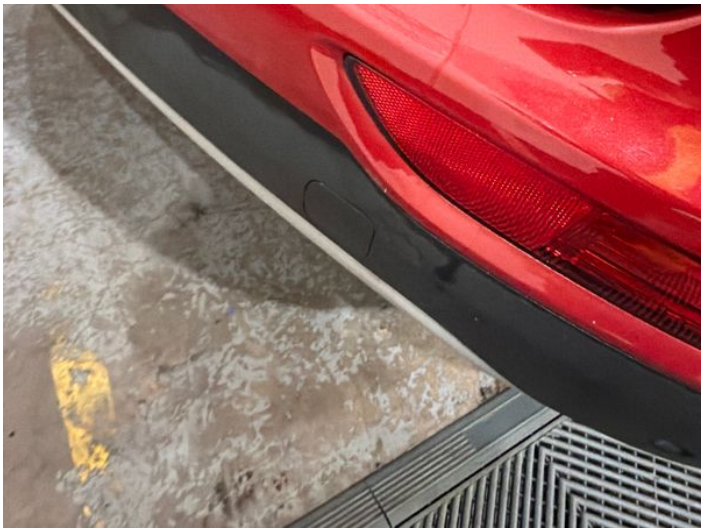
Damage Photos

1: Bonnet
Chipped
1 To 5

2: Bumper Front
Scratched
25 to 100mm Thru Paint

3: Wheel nsf
Scratched
Over 50mm

4: Wing nsf
Chipped
1 To 5

5: Door nsf
Dented
With Paint Damage

6: Door nsr
Scratched
Over 25mm Thru Paint

7: Wheel nsr
Scratched
Up To 50mm

8: Qtr Panel nsr
Dented
2 Or Less UpTo 10mm

9: Qtr Panel nsr
Chipped
1 To 5

10: Bumper Rear
Scratched
Up To 25mm Thru Paint

11: Boot Lid
Scratched
UpTo 25mm Thru Paint

12: Roof
Dented
Over 30mm

13: Qtr Panel osr
Scratched
UpTo 25mm Thru Paint

14: Wheel osr
Scratched
Over 50mm

15: Door osr
Chipped
1 To 5

16: Door osr
Chipped
Edge Chip

17: Door osf
Scratched
Over 25mm Thru Paint

18: Door osr
Dented
2 Or Less UpTo 10mm

19: Wheel osf
Scratched
Over 50mm

20: Wing osf
Chipped
1 To 5
