VEHICLE INSPECTION REPORT

YX13HZA

Kia Sportage 2.0 CRDi KX-3 5dr

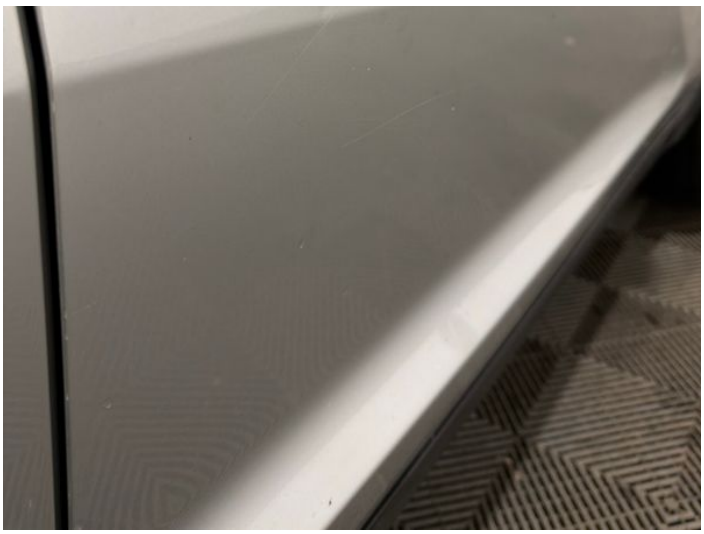
1: Bonnet
Dented
Over 30mm

2: Bonnet
Chipped
Multiple Chips

3: Bumper Front
Scratched
25 to 100mm Thru Paint

4: Bumper Front
Scratched
25 to 100mm Thru Paint

5: Wheel nsf
Scratched
Over 50mm

6: Wing nsf
Chipped
1 To 5

7: A Post ns
Chipped
1 To 5

8: Door nsf
Dented
With Paint Damage

9: Door nsr
Dented
Between 10mm + 30mm
Multiple dents

10: Door nsr
Scratched
Over 25mm Thru Paint

11: Wheel nsr
Scratched
Over 50mm

12: Other
N/A
N/A
Roof rails scratched

13: Qtr Panel nsr
Scratched
Over 25mm Thru Paint

14: Boot Lid
Scratched
Over 25mm Thru Paint

15: Parking Sensor Rear
Broken
Replace

16: Qtr Panel osr
Dented
Between 10mm + 30mm

17: Qtr Panel osr
Scratched
UpTo 25mm Thru Paint

18: Wheel osr
Scratched
Over 50mm

19: Door osr
Chipped
1 To 5

20: Door osf
Dented
Between 10mm + 30mm

21: Door osf
Scratched
Over 25mm Thru Paint

22: Wing osf
Chipped
1 To 5

23: Wheel osf
Scratched
Over 50mm

24: Screen Front
Chipped
UpTo 10mm
