46 Brampton Road
Eastbourne
BN22 9BN
01323 520295 | no-reply@ebca.co.uk

VEHICLE INSPECTION REPORT

LS69VDT

Nissan X-Trail 1.7 dCi N-Connecta 5dr [7 Seat]

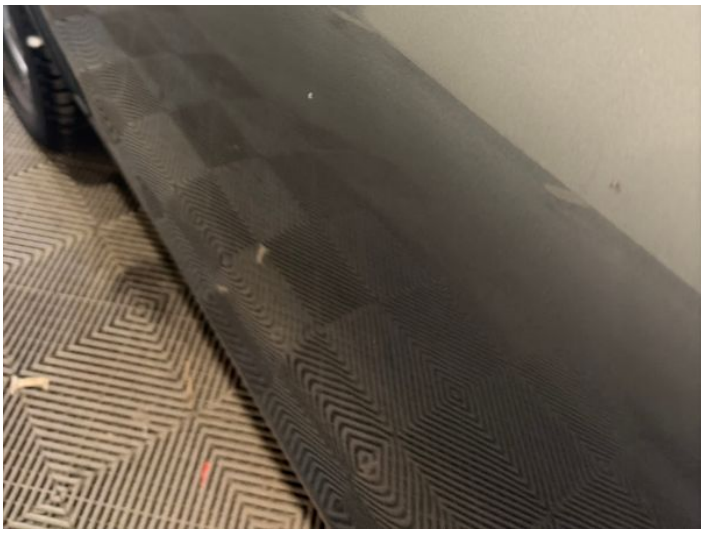
1: Bonnet
Chipped
Multiple Chips

2: Bumper Front
Scratched
25 to 100mm Thru Paint

3: Bumper Front
Scratched
25 to 100mm Thru Paint

4: Wheel nsf
Scratched
Over 50mm

5: Door nsf
Dented
Between 10mm + 30mm

6: Door nsf
Chipped
1 To 5

7: Door nsr
Chipped
Edge Chip

8: Wheel nsr
Scratched
Up To 50mm

9: Bumper Rear
Scratched
25 to 100mm Thru Paint

10: B Post ns
Dented
Between 10mm + 30mm

11: Wheel osr
Corroded
Light

12: Qtr Panel Arch Extension os
Scuffed (Unpainted)
Over 100mm

13: Door osr
Scratched
Over 25mm Thru Paint

14: Door osf
Poor Previous Repair
Rippled UpTo 30%

15: Wing osf
Scratched
Over 25mm Thru Paint

16: Roof
Chipped
1 To 5

17: Screen Front
Chipped
Over 10mm
