VEHICLE INSPECTION REPORT

WR17UHM

Nissan X-Trail 1.6 DiG-T Visia 5dr

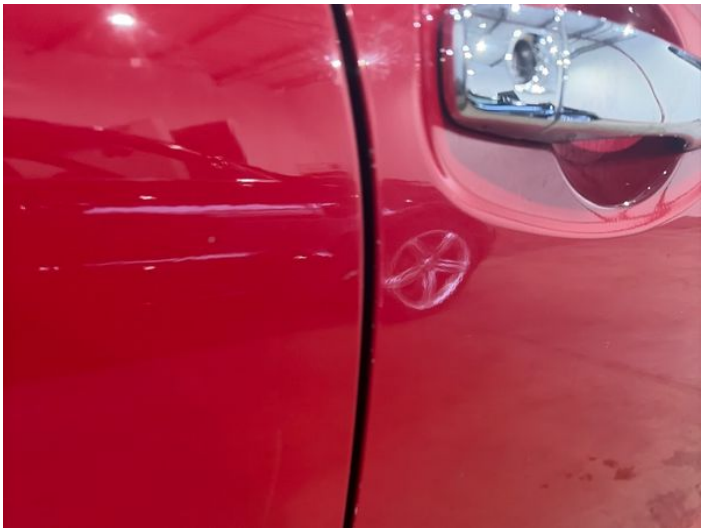
Damage Photos

1: Wing osf
Chipped
1 To 5

2: Door osf
Chipped
1 To 5

3: Door osr
Scratched
Over 25mm Thru Paint

4: Door osf
Chipped
Edge Chip

5: Qtr Panel osr
Dented
2 Or Less UpTo 10mm

6: Bumper Rear
Scratched
25 to 100mm Thru Paint

7: Wheel nsr
Scratched
Up To 50mm

8: Qtr Panel nsr
Scratched
UpTo 25mm Thru Paint

9: Door nsr
Scratched
Over 25mm Thru Paint

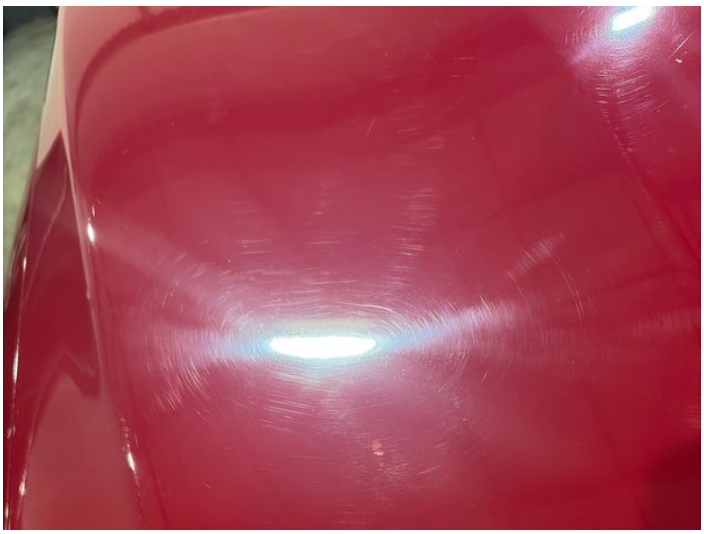
10: Door nsf
Scratched
UpTo 25mm Thru Paint

11: Wing nsf
Poor Previous Repair
Poor Paint

12: Bumper Front
Scratched
25 to 100mm Thru Paint

13: Bonnet
Chipped
1 To 5

14: Screen Front
Chipped
UpTo 10mm
