VEHICLE INSPECTION REPORT

GL18EHG

Skoda Fabia 1.0 TSI SE 5dr

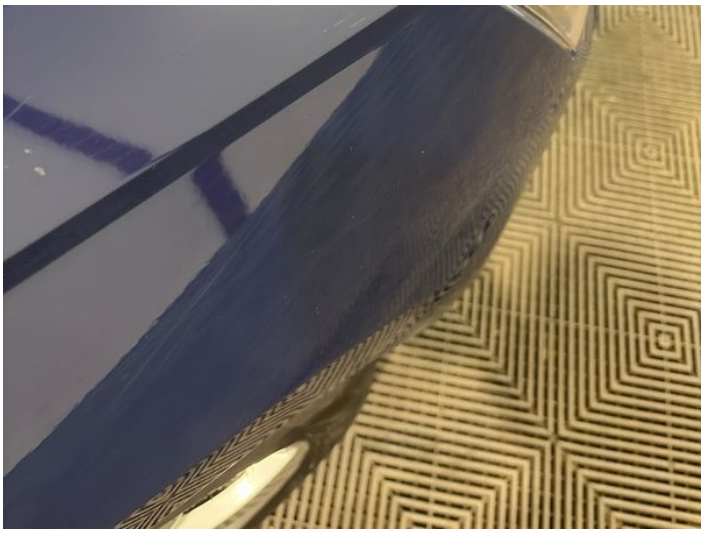
1: Wheel osf
Scratched
Over 50mm

2: Wing osf
Chipped
1 To 5

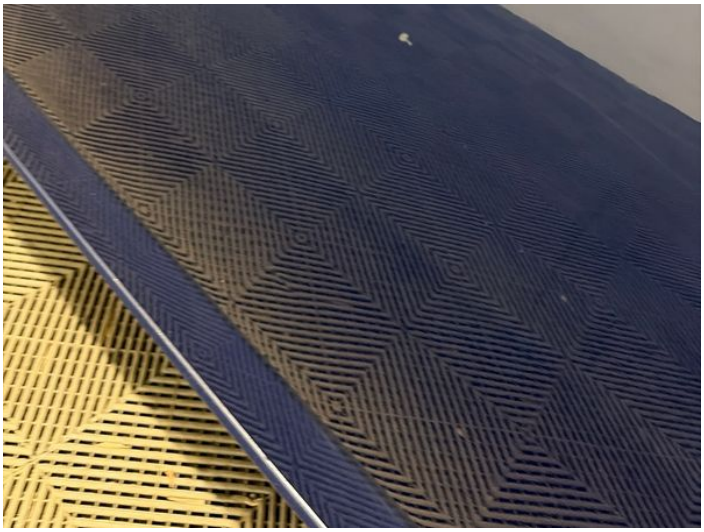
3: Door osf
Chipped
1 To 5

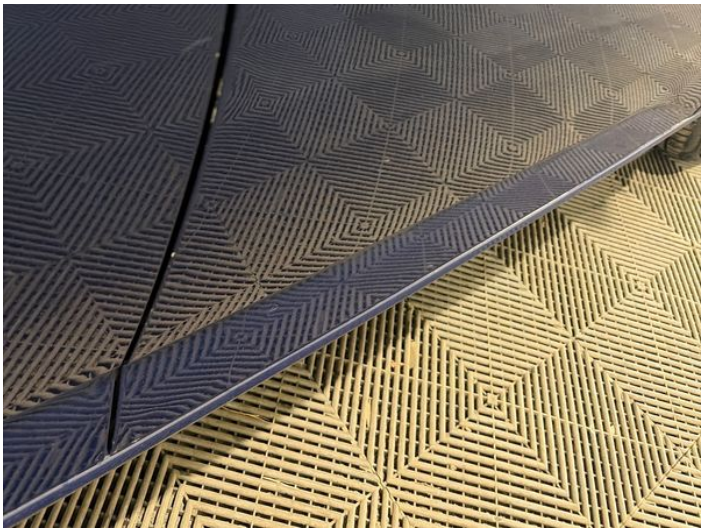
4: Door osf
Chipped
Edge Chip

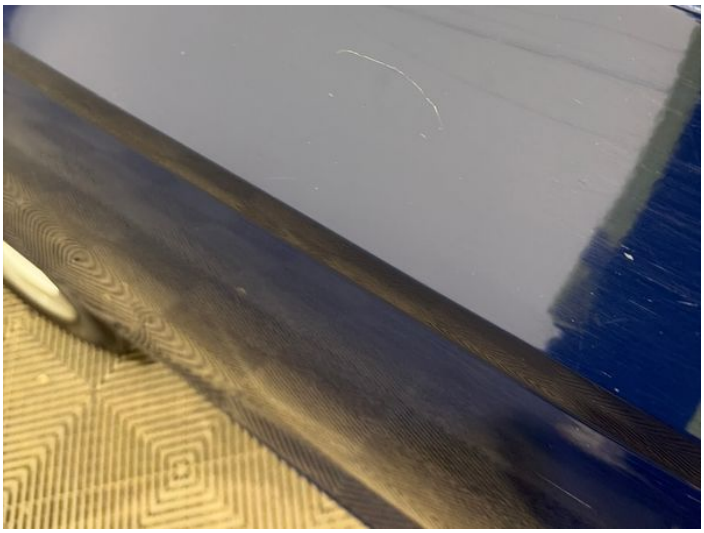
5: Door osr
Scratched
Over 25mm Thru Paint

6: Wheel osr
Scratched
Up To 50mm

7: Qtr Panel osr
Dented
With Paint Damage

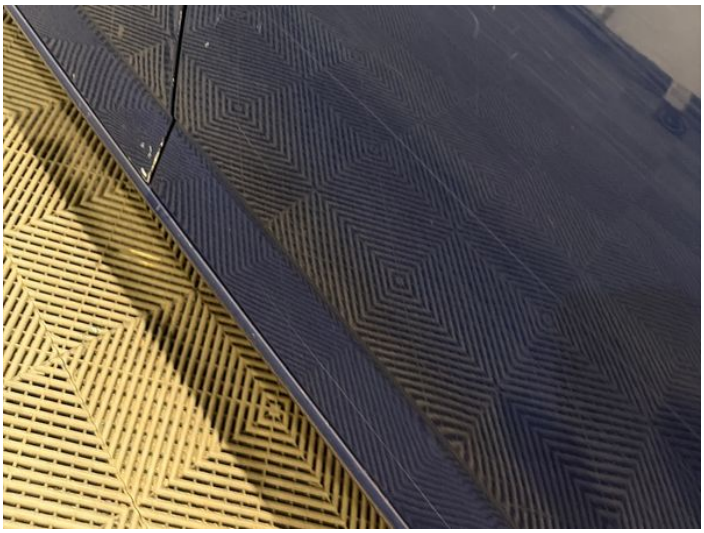
8: Bumper Rear
Scratched
Over 100mm Thru Paint

9: Qtr Panel nsr
Scratched
Over 25mm Thru Paint

10: Wheel nsr
Scratched
Over 50mm

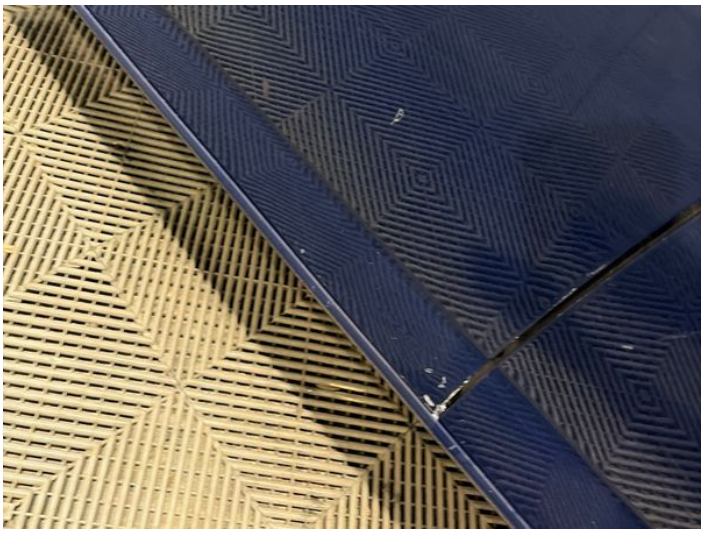
11: Door nsr
Scratched
Over 25mm Thru Paint

12: Door nsf
Chipped
Multiple Chips

13: Door Mirror Assy nsf
Scratched (Painted)
UpTo 25mm Thru Paint

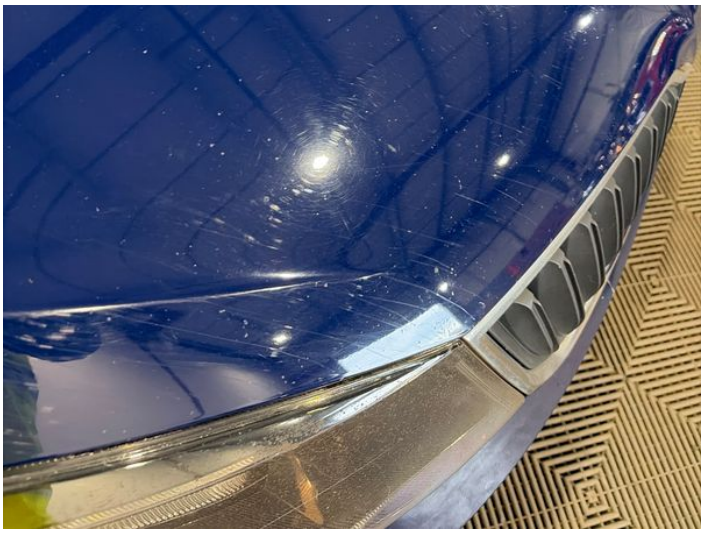
14: Wing nsf
Dented
With Paint Damage

15: Wheel nsf
Scratched
Over 50mm

16: Bumper Front
Scratched
Over 100mm Thru Paint

17: Bonnet
Chipped
Multiple Chips

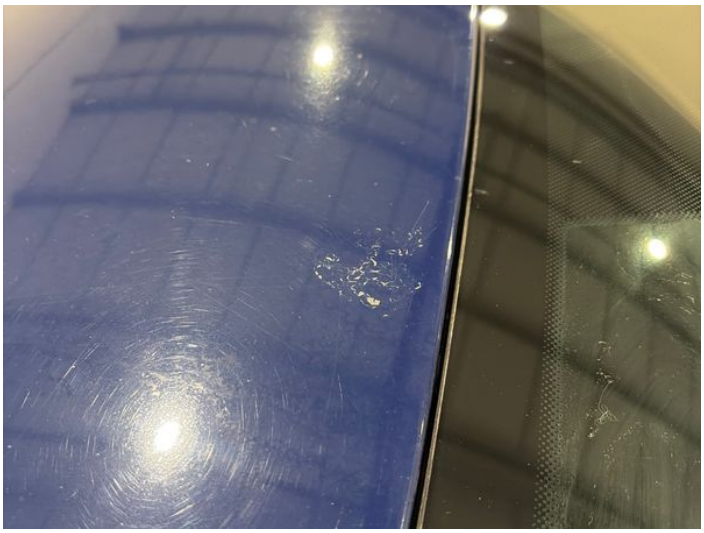
18: Roof
Poor Previous Repair
Paint Flake

19: Boot Lid
Dented
Between 10mm + 30mm

20: Carpets Front
Holed
Over 3mm
