# VEHICLE INSPECTION REPORT

**ST66LBJ**

## Volkswagen Touran 1.6 TDI 115 SE Family 5dr

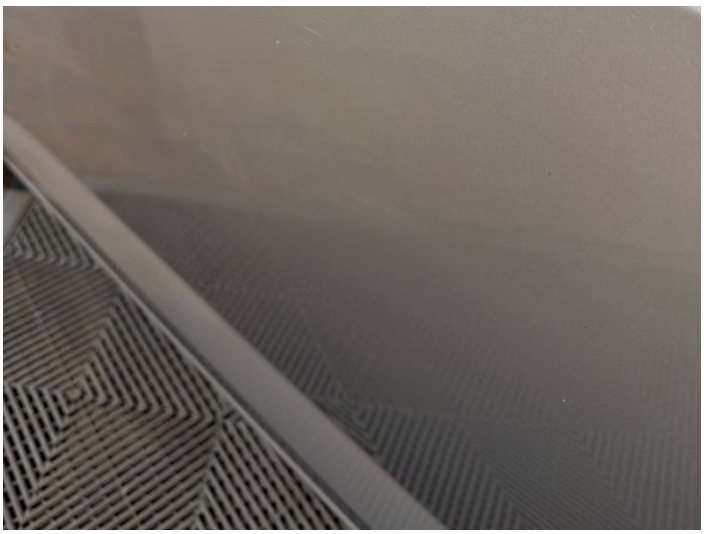
1: Bonnet
Chipped
1 To 5

2: Bumper Front
Scratched
25 to 100mm Thru Paint

3: Bumper Front
Scratched
25 to 100mm Thru Paint

4: Wing nsf
Dented
Between 10mm + 30mm

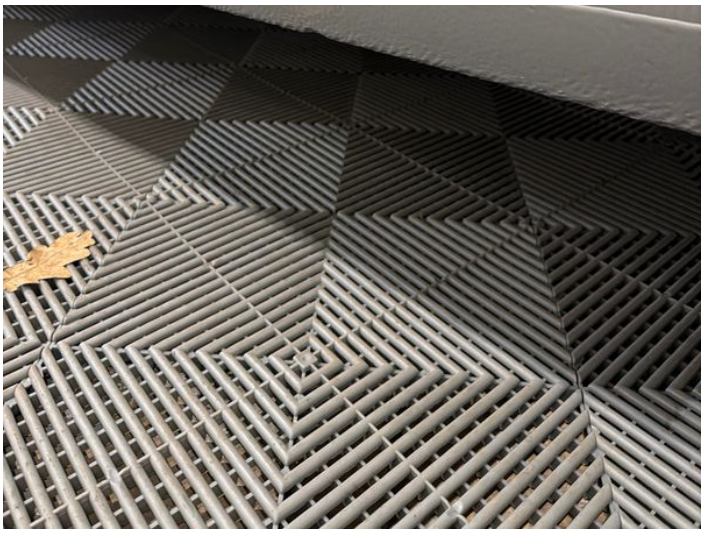
5: Wing nsf
Chipped
1 To 5

6: Wheel nsf
Scratched
Over 50mm

7: Door Mirror Assy nsf
Scratched (Painted)
UpTo 25mm Thru Paint

8: Door nsf
Scratched
UpTo 25mm Thru Paint

9: Door nsr
Scratched
UpTo 25mm Thru Paint
