VEHICLE INSPECTION REPORT

MA12WDN

Nissan Qashqai+2 1.5 dCi [110] N-Tec+ 5dr

Eastbourne Car Auctions

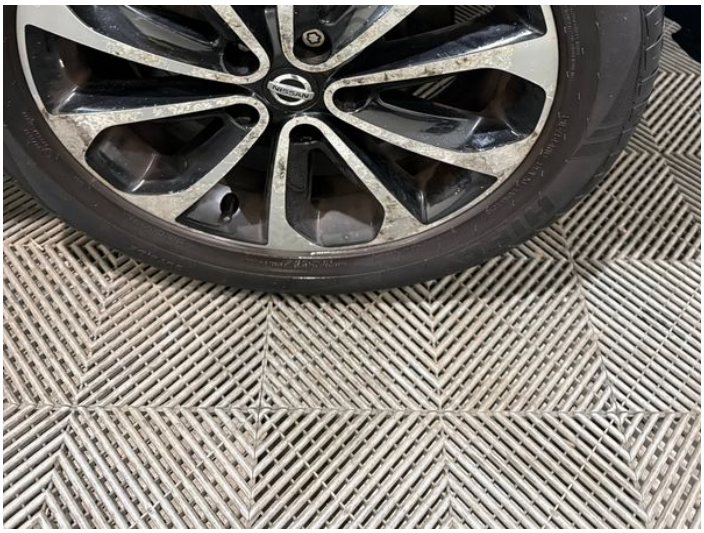
10: Door nsf
Dented
Between 10mm + 30mm
Multiple dents

11: Door nsf
Chipped
Multiple Chips

12: Door nsr
Scratched
Over 25mm Thru Paint

13: Wheel nsr
Scratched
Over 50mm

14: Qtr Panel nsr
Scratched
Over 25mm Thru Paint

15: Bumper Rear
Insecure
Action Required

16: Bumper Rear
Dented
With Paint Damage

17: Boot Lid
Poor Previous Repair
Poor Paint

18: Qtr Panel osr
Chipped
1 To 5

19: Wheel osr
Scratched
Over 50mm

20: Door osr
Dented
Between 10mm + 30mm
Multiple dents

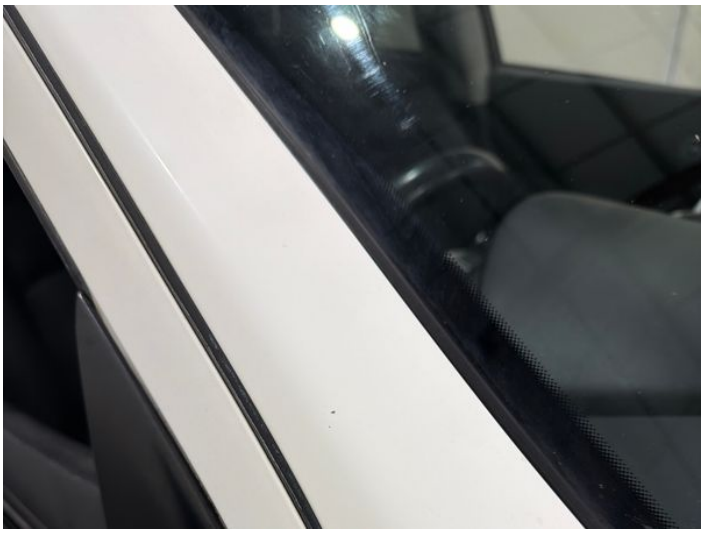
21: Door osf
Dented
Over 30mm

22: Door osf
Chipped
Edge Chip

23: Door Mirror Assy osf
Scratched (Painted)
Over 25mm Thru Paint

24: A Post os
Chipped
1 To 5

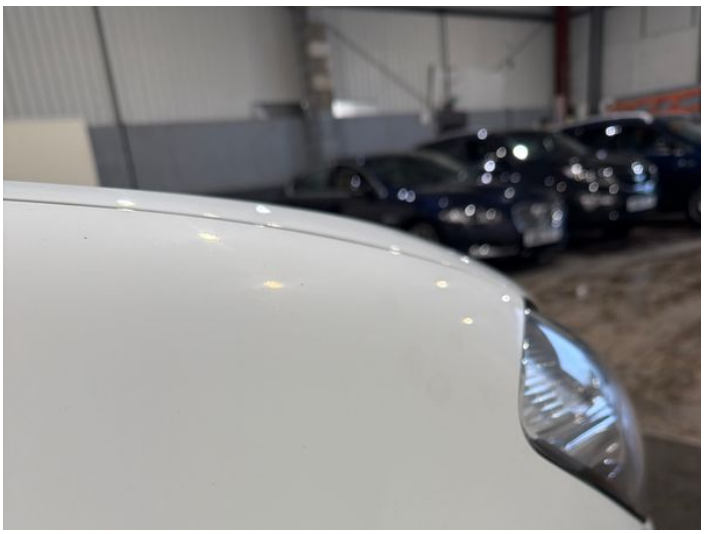
25: Wing osf
Dented
Between 10mm + 30mm

26: Wing osf
Chipped
1 To 5

27: Wheel osf
Scratched
Over 50mm

28: Other
N/A
N/A
Roof rails scratched

29: Screen Front
Chipped
UpTo 10mm

30: Door Pad osf
Scuffed
Over 25mm

31: Seat Base Cover osr
Torn
Over 3mm

32: Seat Base Cover nsr
Holed
UpTo 3mm

33: Door Pad nsf
Scuffed
Over 25mm

34: Handle Outer nsf
Scratched (Painted)
UpTo 25mm Thru Paint
