VEHICLE INSPECTION REPORT

KS73JAU

Vauxhall Mokka 100kW Ultimate 50kWh 5dr Auto

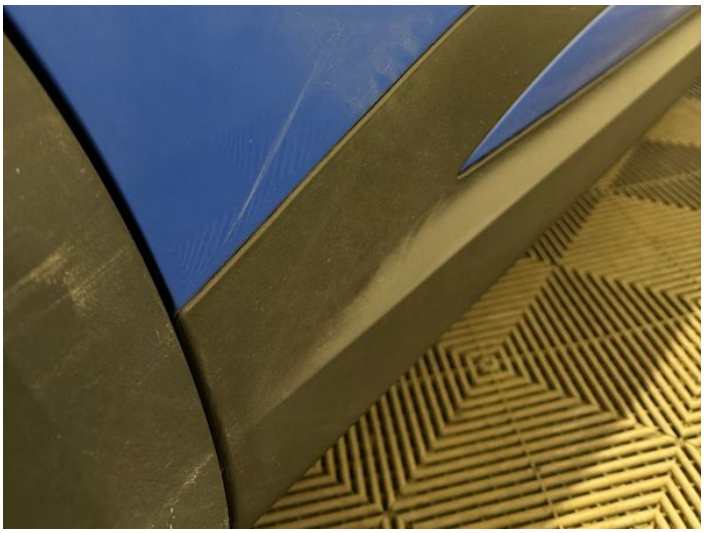
Damage Photos

1: Bonnet
Chipped
1 To 5

2: Bumper Front
Scratched
25 to 100mm Thru Paint

3: Wheel nsf
Scratched
Over 50mm

4: Door Mirror Assy nsf
Scratched (Painted)
Over 25mm Thru Paint

5: A Post ns
Chipped
1 To 5

6: Door nsf
Chipped
Edge Chip

7: Door nsr
Scratched
UpTo 25mm Thru Paint

8: Wheel nsr
Scratched
Up To 50mm

9: Bumper Rear
Scratched
25 to 100mm Thru Paint

10: Wheel osr
Scratched
Over 50mm

11: Door osr
Scratched
Over 25mm Thru Paint

12: Qtr Panel Moulding os
Scuffed (Unpainted)
Over 100mm

13: Door osf
Chipped
Edge Chip

14: Roof
Chipped
1 To 5

15: Screen Front
Chipped
UpTo 10mm

16: Wheel osf
Scratched
Over 50mm

17: Wing Front Arch Extension os
Scuffed (Unpainted)
UpTo 100mm

18: Seat Base Cover osf
Soiled
Light

19: Tyre nsr
Damaged
Replace

20: Wing nsf
Dented
2 Or Less UpTo 10mm
