VEHICLE INSPECTION REPORT

NV12KMM

Kia Venga 1.6 2 5dr Auto

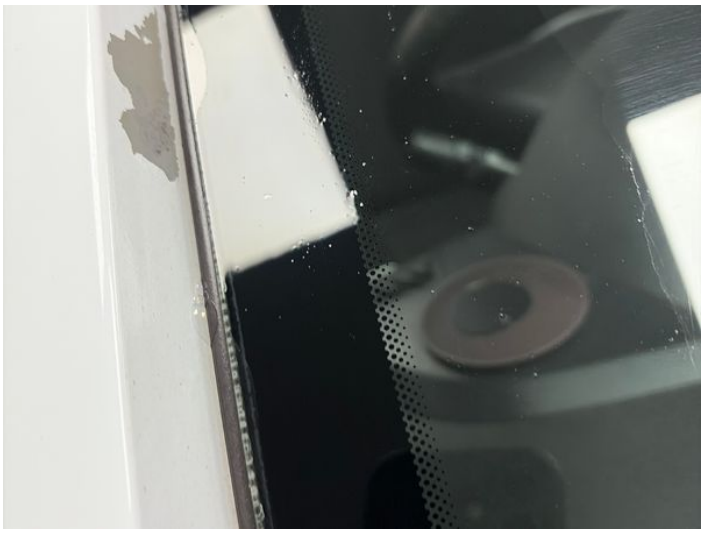
16: Roof
Poor Previous Repair
Poor Paint

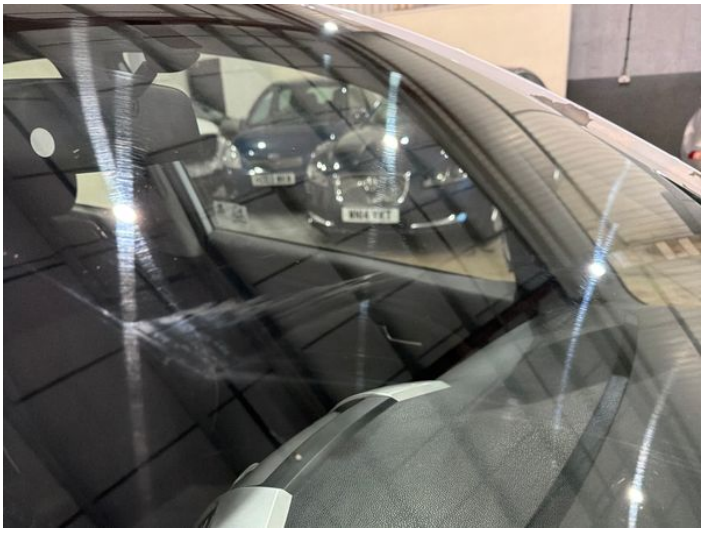
17: A Post ns
Poor Previous Repair
Paint Flake
