VEHICLE INSPECTION REPORT

GU19NGE

Volvo XC90 2.0 D5 PowerPulse Momentum 5dr AWD Geartronic

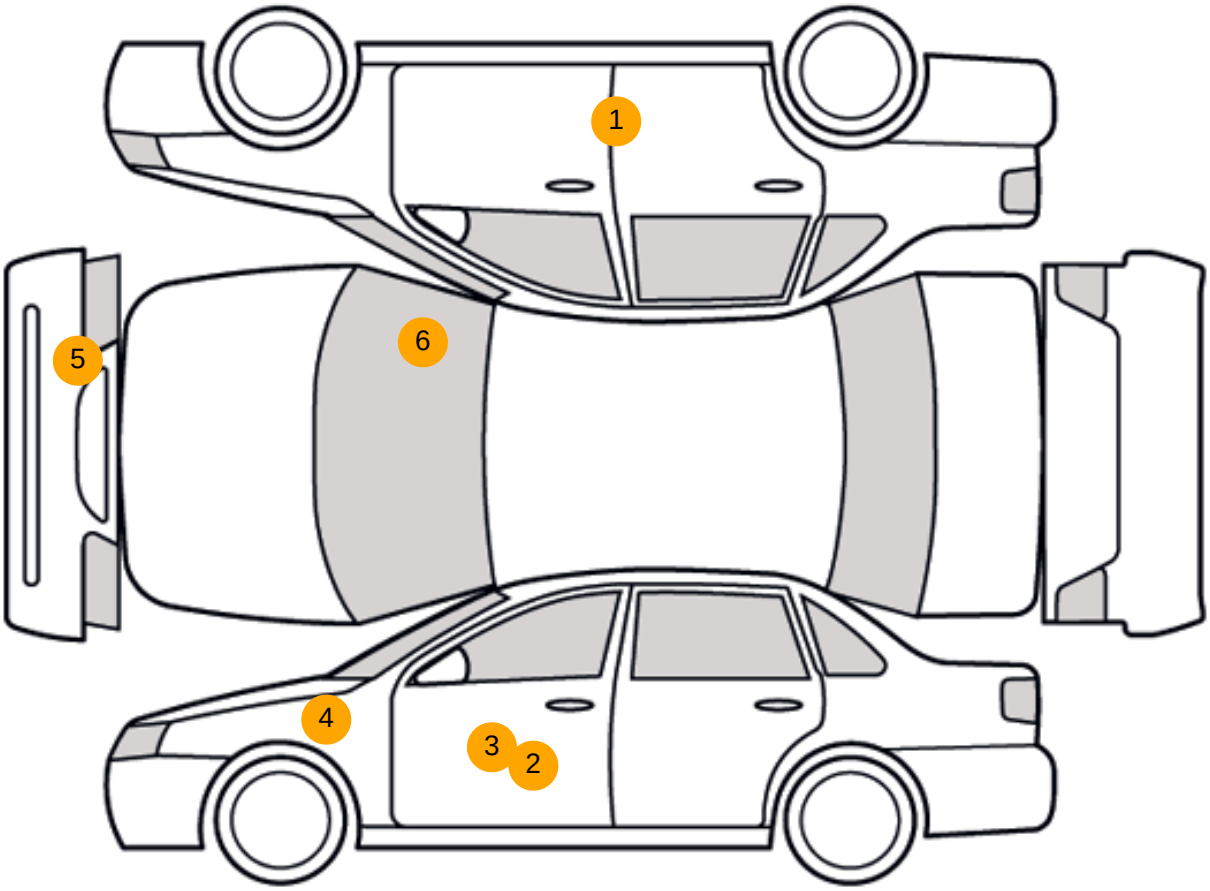
1: Door osf
Chipped
Edge Chip

2: Door nsf
Chipped
1 To 5

3: Door nsf
Dented
2 Or Less UpTo 10mm

4: Wing nsf
Chipped
1 To 5

5: Bumper Front
Chipped
1 To 5

6: Screen Front
Chipped
UpTo 10mm
